# Inspection Report

**VALUE GUARANTEED INSPECTIONS**

1234 W Filmore Ave

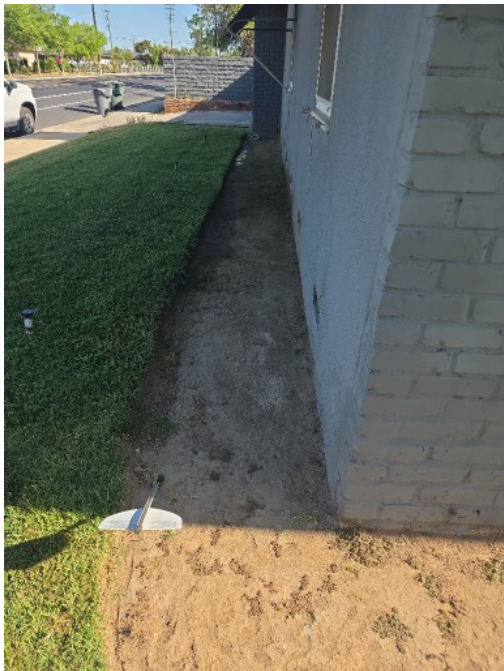
#### 1.1) Grading Conditions

The visible areas of the sidewalk appeared to be in serviceable condition at the time of the inspection. Grading of the soil near the foundation appears to be in serviceable condition.

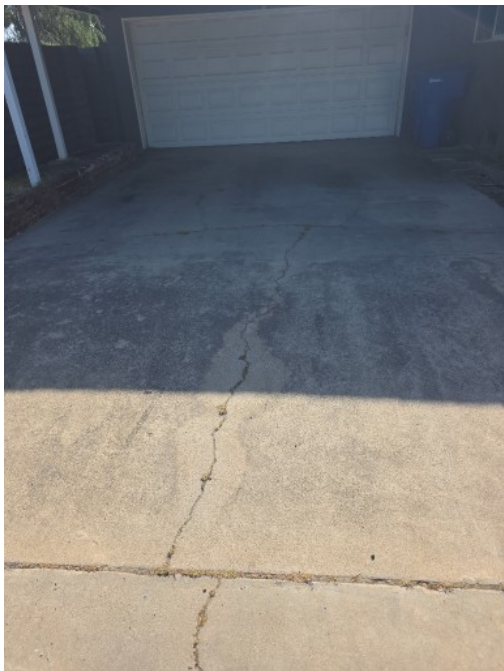
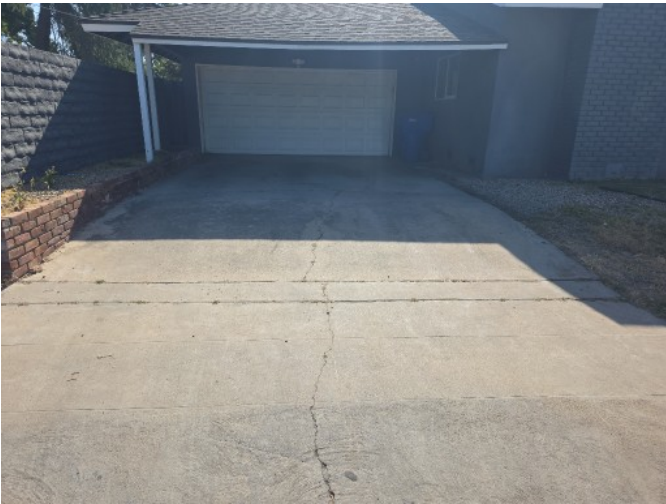
**1.2) Driveway Conditions**

Common cracks and settlement were observed. Sealant is recommended on the driveway as part of normal maintenance.

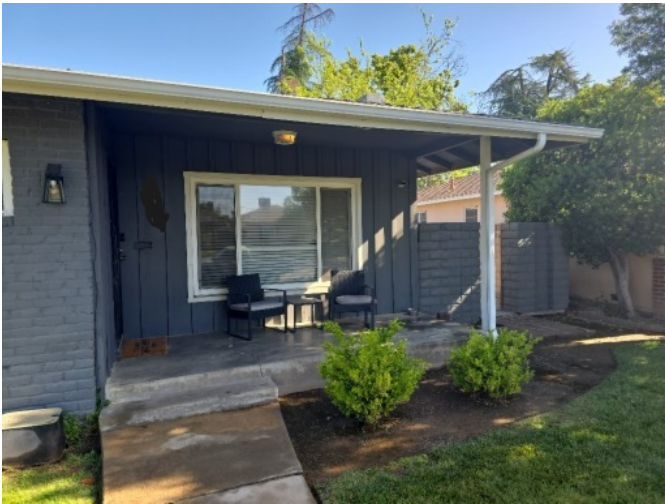
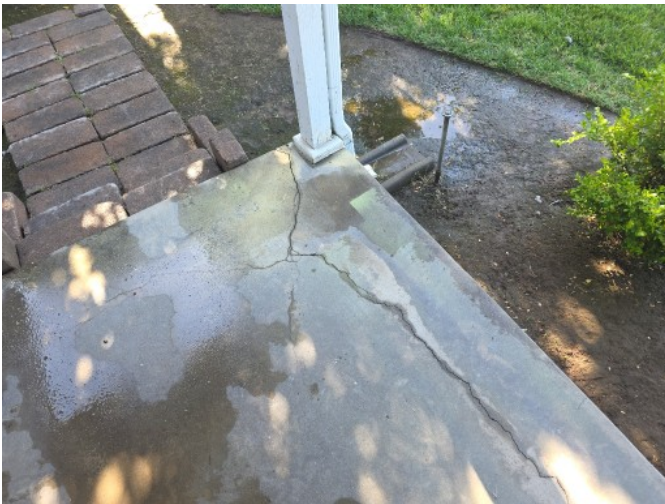
#### 2.1) Front Entrance Conditions

The visible and accessible areas of the porch appeared to be in serviceable condition at the time of the inspection. Minor settlement was observed at the porch. Although no immediate concern was observed at the time of inspection, recommend sealing along wall, or any settled areas. Over time, settlement can cause water penetration at the house wall. No railings were present. For increased safety, client should consider installation of a railing. Client should consult with a qualified contractor for information on current standards.

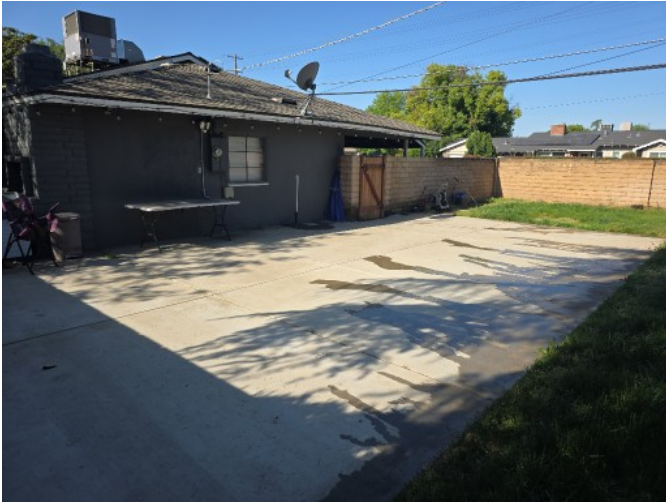
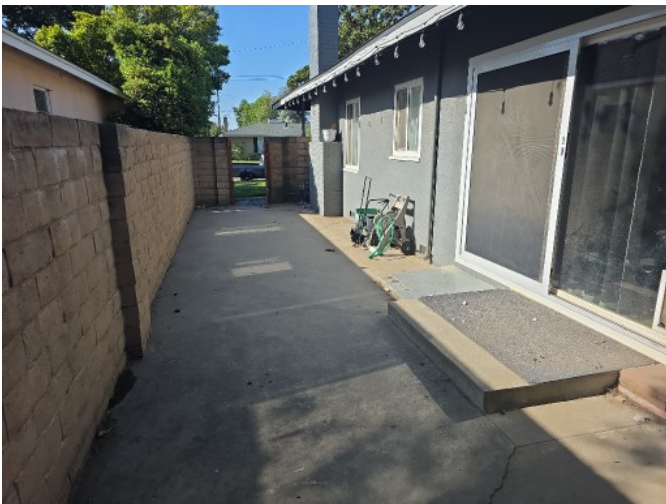
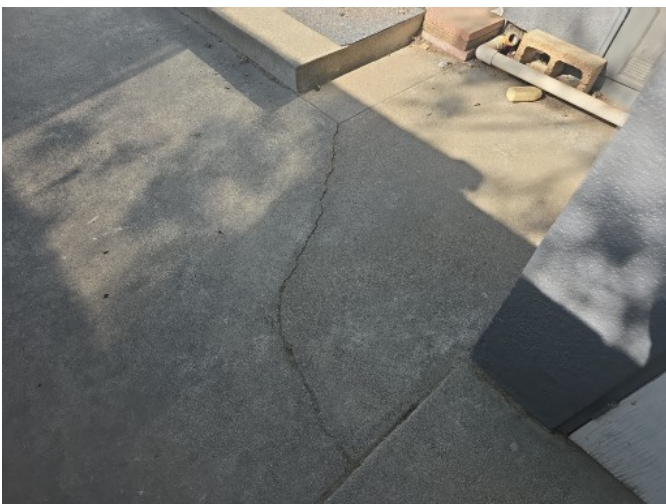
#### 2.2) Back Entrance Conditions

The visible portions of the patio appeared to be in serviceable condition at the time of the inspection. Substantial cracks and / or settlement were observed in the patio.

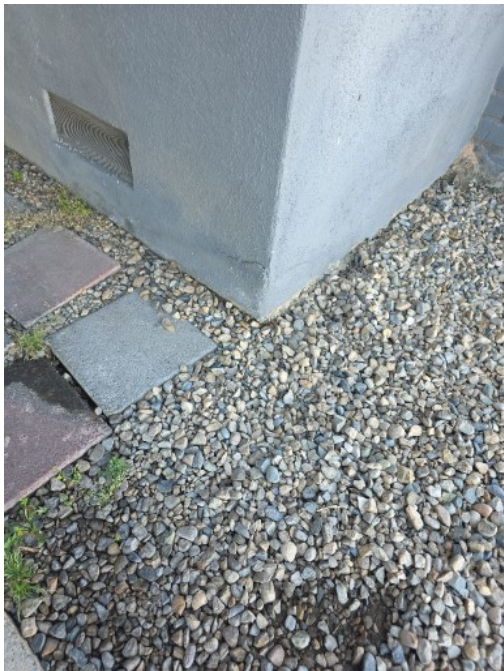
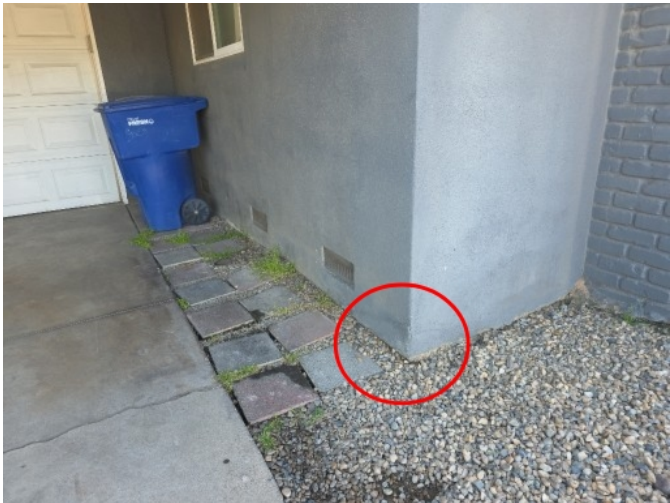
2.3) Exterior Wall Conditions

The visible and accessible portions of the exterior wall coverings appeared to be in serviceable condition at the time of the inspection.Common cracks were found in the exterior walls. Recommend sealing to reduce the possibility of water penetration.

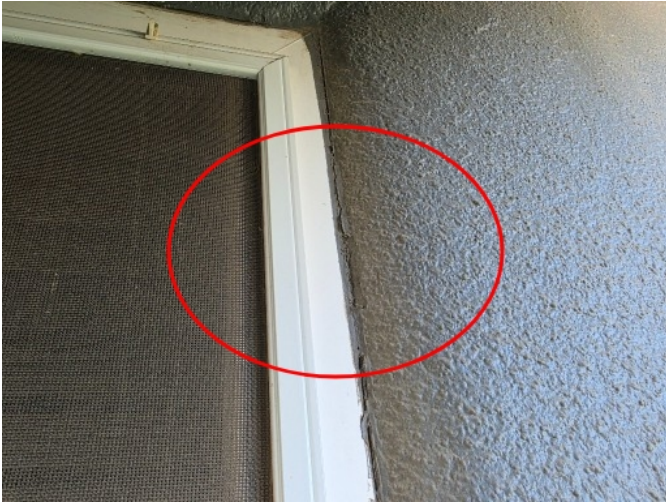
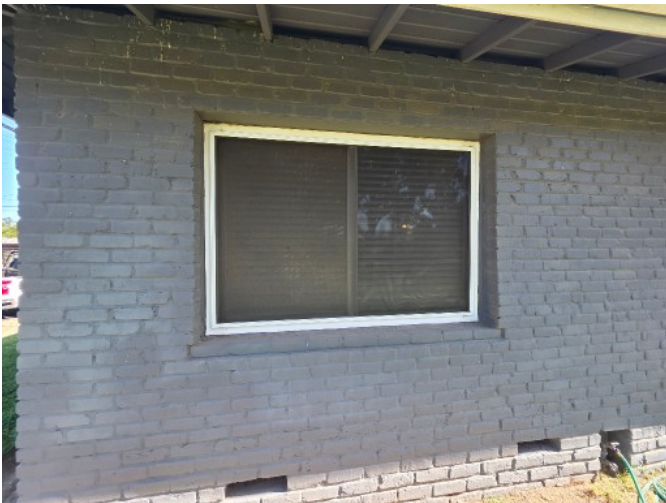
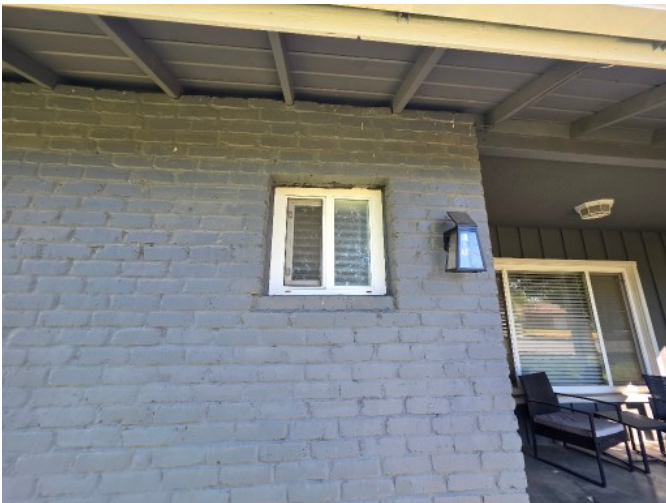
2.4) Window Conditions

Exterior frame weathering and some deterioration was observed. Recommend repairs / maintenance as needed. Water penetration may have occurred.

Several windows were noted to be sticking, likely due to settling or humidity-related expansion. This may require adjustment or maintenance for smooth operation.

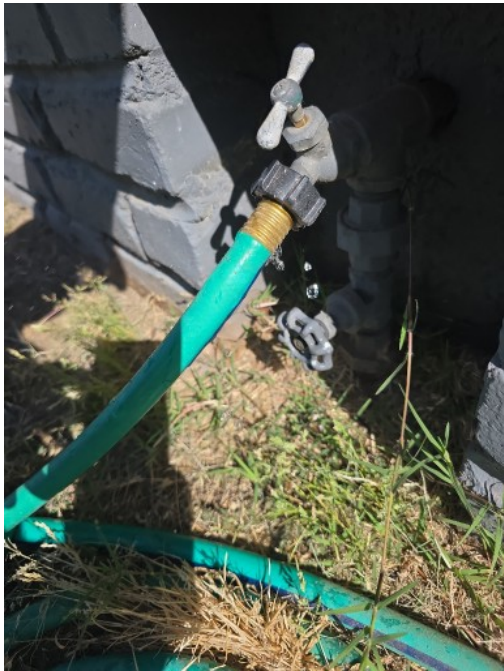
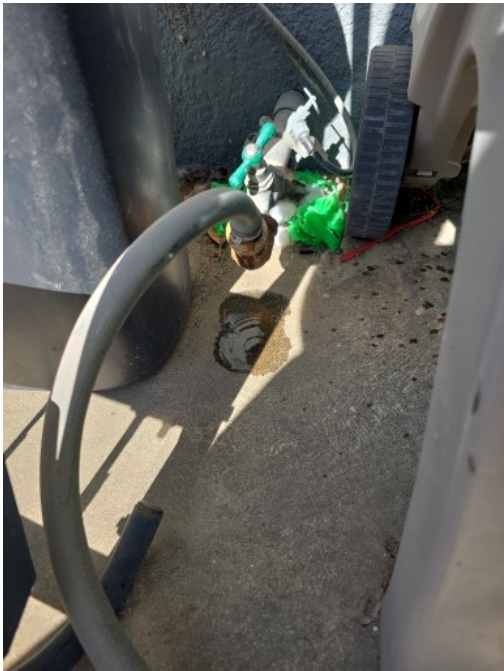
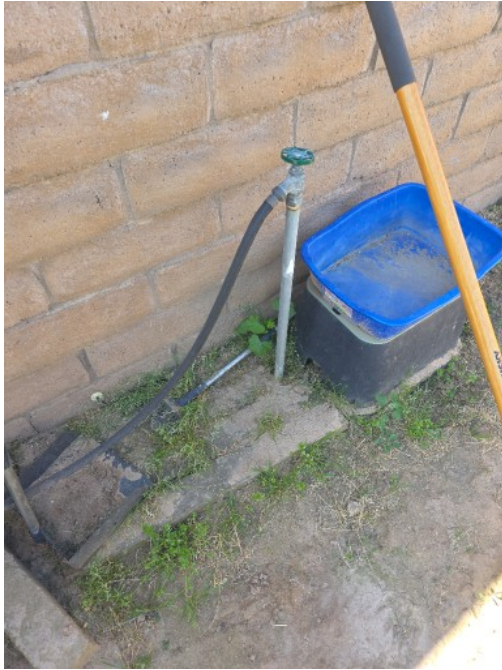
2.6) Faucet Conditions

Hose faucet/pipe was loose, recommend securing.

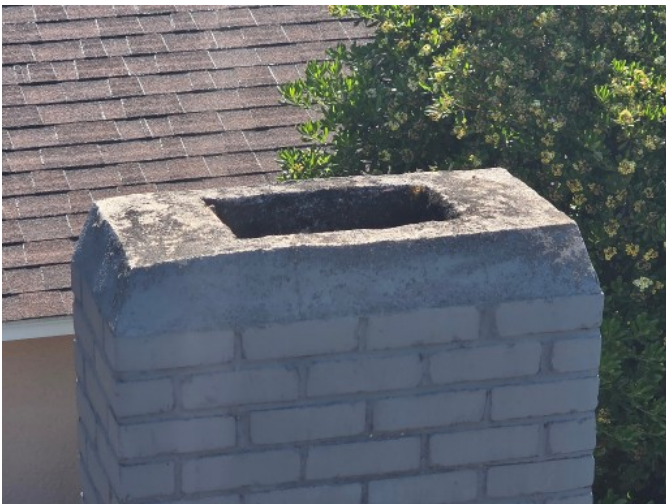
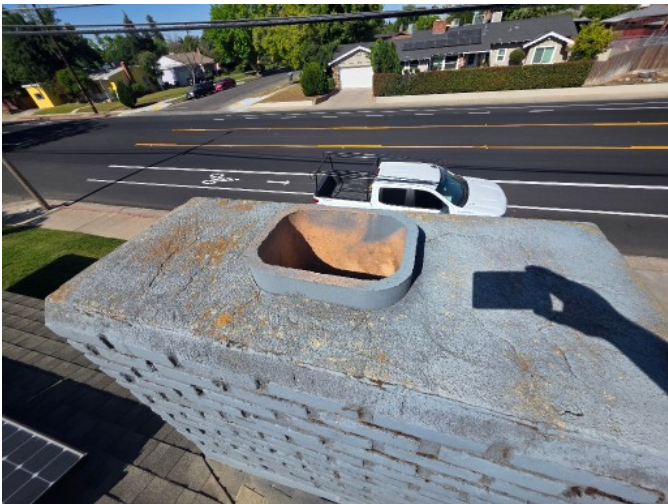
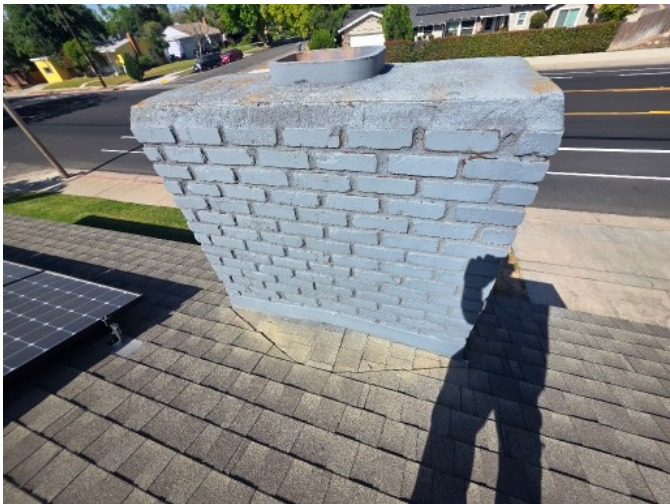
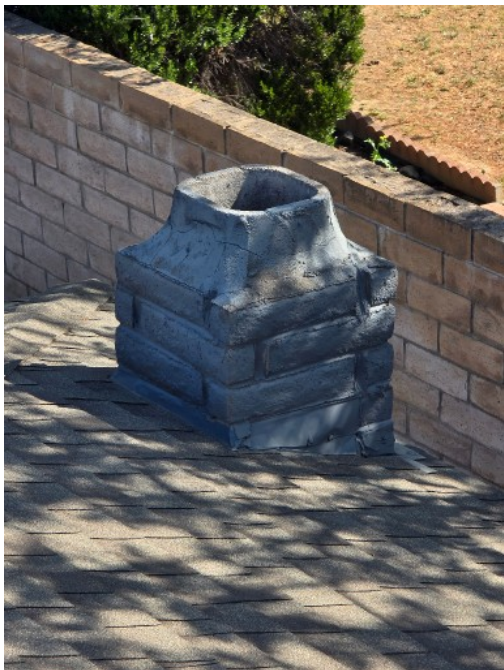
### 2.7) Chimney Conditions

Common cracks were observed at the chimney and / or cap. Recommend all cracks be sealed and / or re-pointed as part of normal maintenance to prevent widening of cracks. The chimney and / or flue did not have a spark screen installed. Recommend installation of a spark screen as a safety enhancement. The chimney and / or flue did not have a rain cap installed. Recommend a cap be installed during normal chimney maintenance.

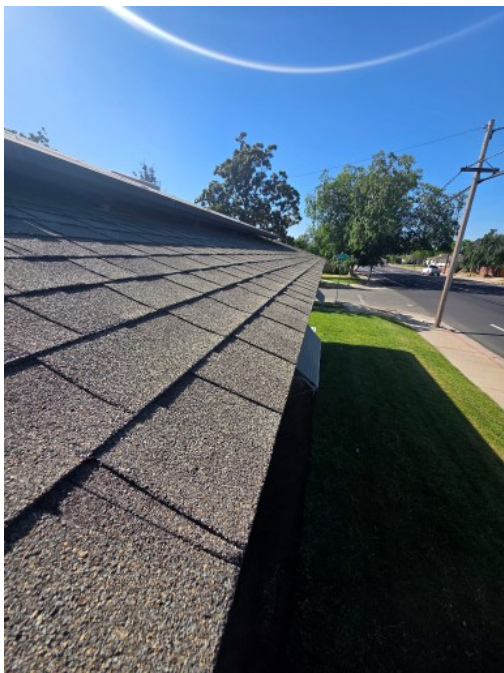
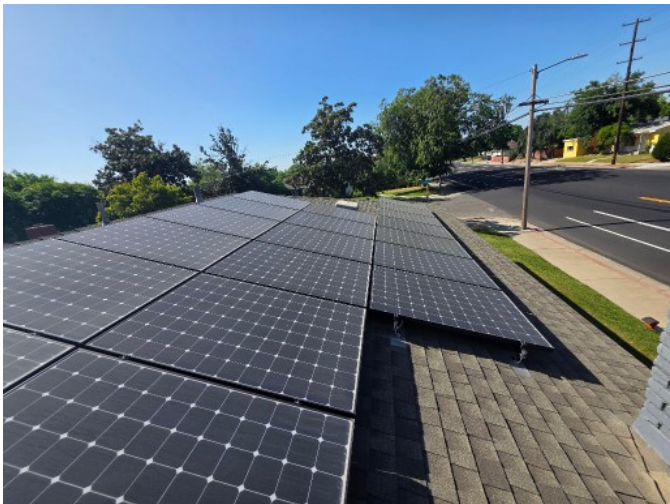
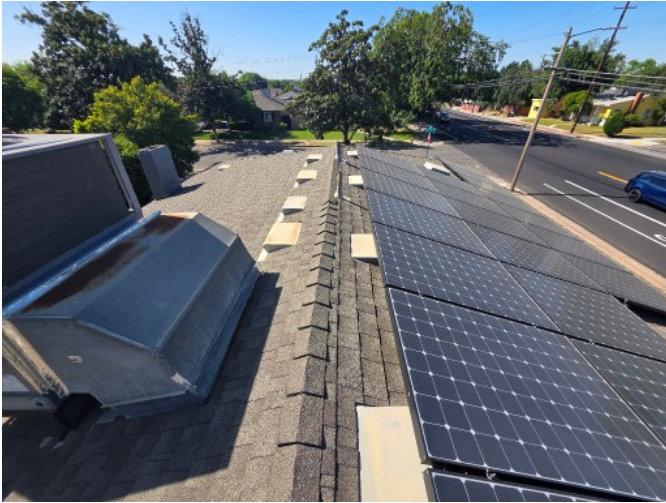
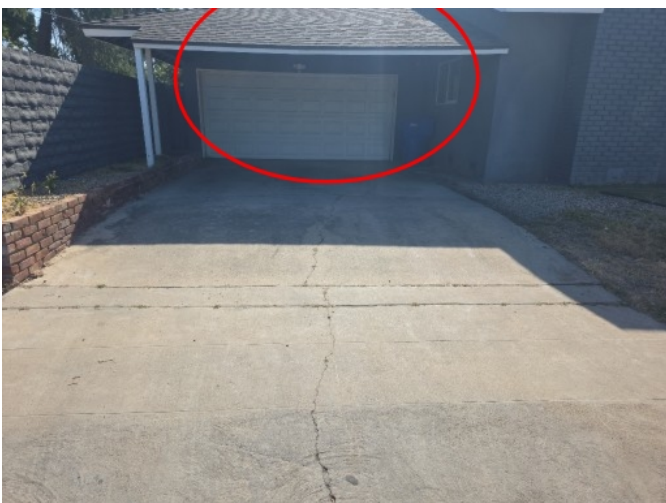
3.1) Roof Covering Condition

The roof covering shows normal wear for its age and appeared to be in serviceable condition at the time of the inspection.Minor sagging or depressions were observed to the roof sheathing and / or framing support at the garage car port.

Minor sagging was observed at the carport roofline. While not currently critical, it is advisable to monitor this area and consider reinforcement to prevent further settling.

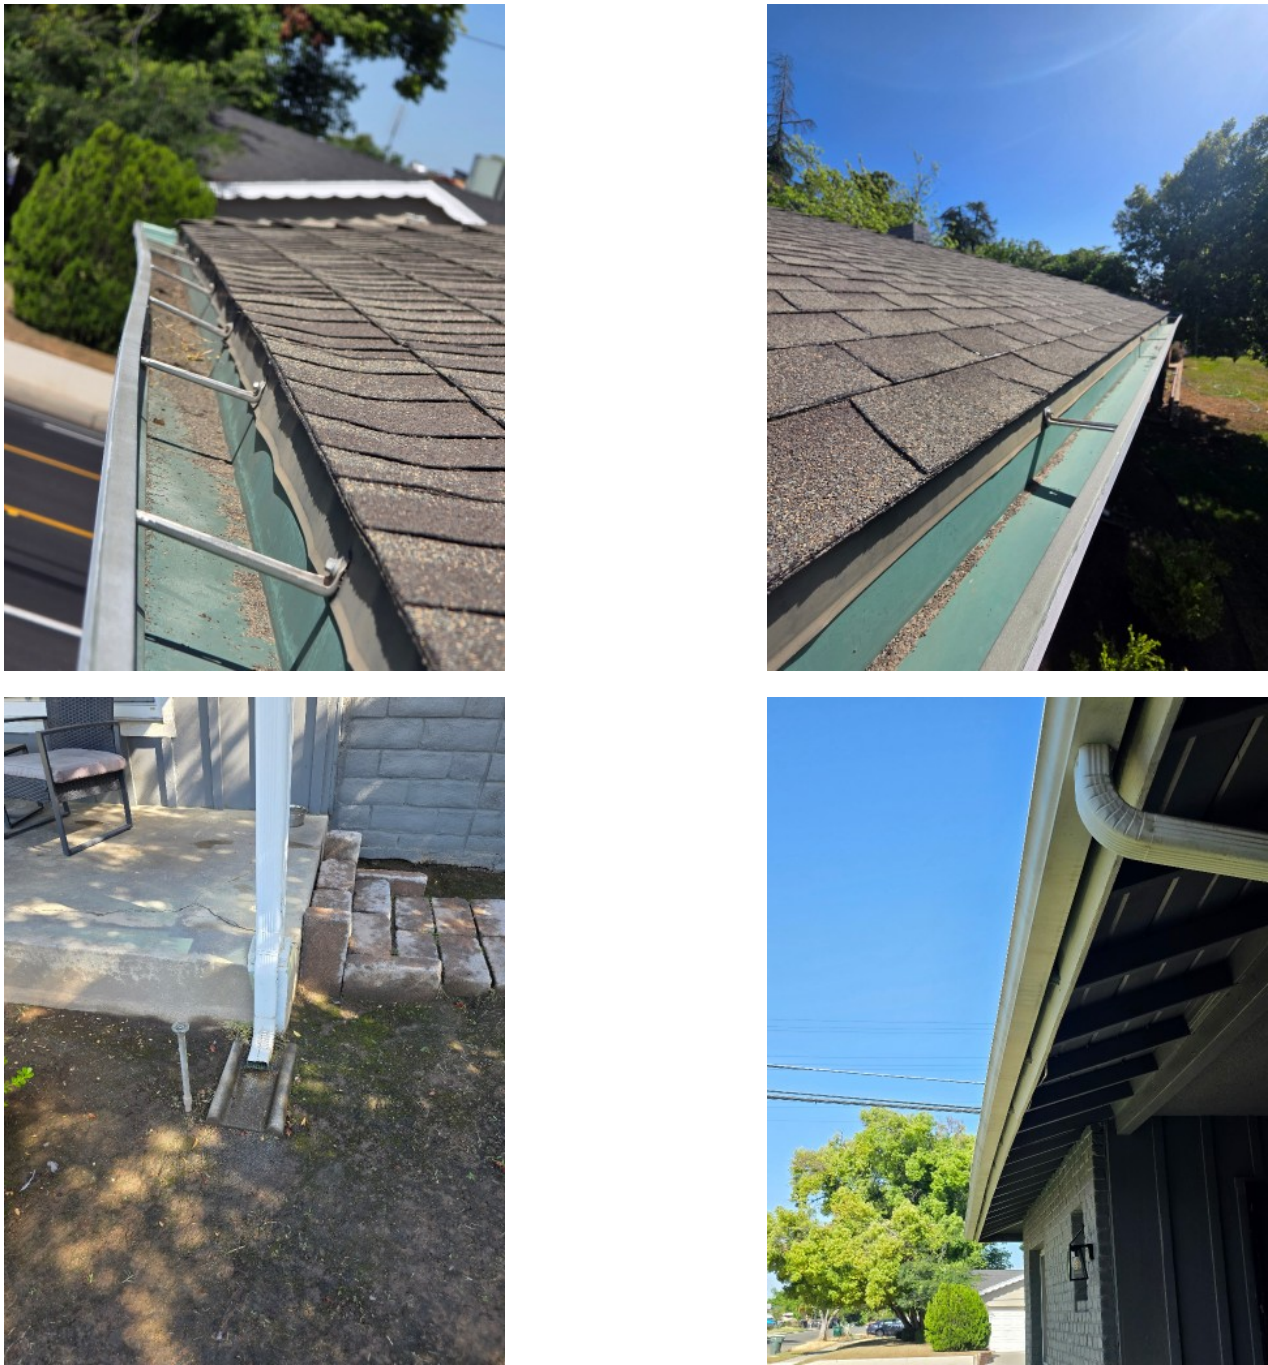
### 3.3) Gutter & Downspout Conditions

The gutter system appeared to be in serviceable condition at the time of the inspection. The property has a partial gutter system. Recommend adding gutters and downspouts where needed. Water seepage into crawl spaces, basements and under foundations are primarily caused by inadequate removal of rainwater from the perimeter of the house.

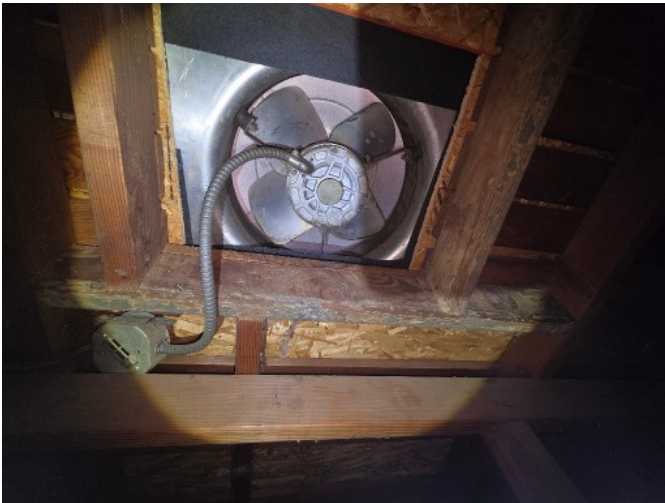
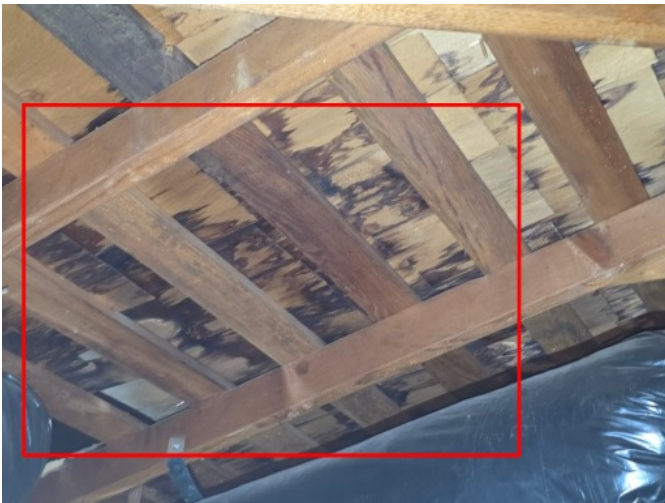
### 3.4) Attic Conditions

The powered ventilation fan was operational at the time of the inspection. This does not however guarantee future conditions. Minor water stains were observed. The inspector was unable to determine if the water stains were active at the time of the inspection. The stains may have been caused by condensation or leakage at a previous time. The inspector does not offer an opinion or warranty as to whether the roof leaks now (unless it is moderately raining at the time of inspection) or is subject to future leakage. Client should obtain disclosure / history information from the current owner or occupant prior to close.

Water stains were visible on the roof sheathing and in the crawlspace, suggesting possible past moisture intrusion. These areas were dry at the time of inspection, but further evaluation is recommended to confirm no active leaks and ensure proper ventilation and drainage.

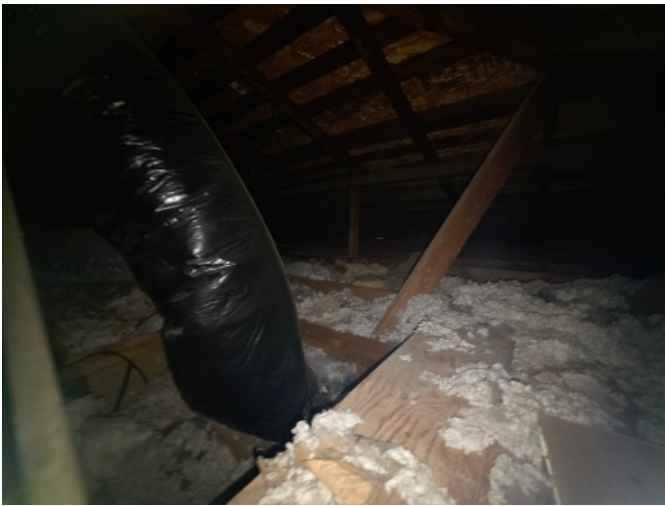
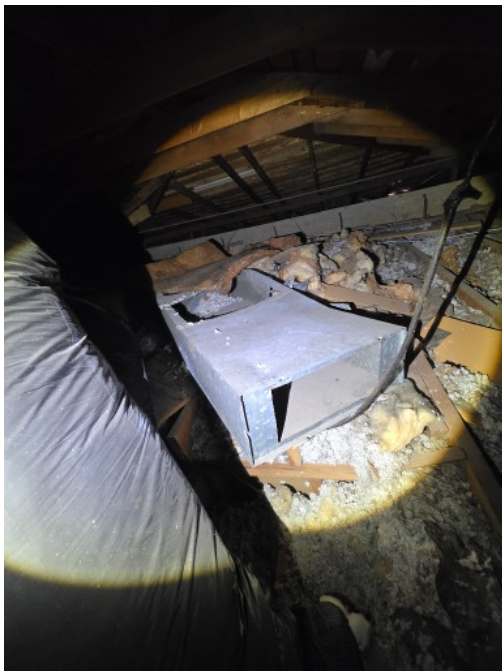
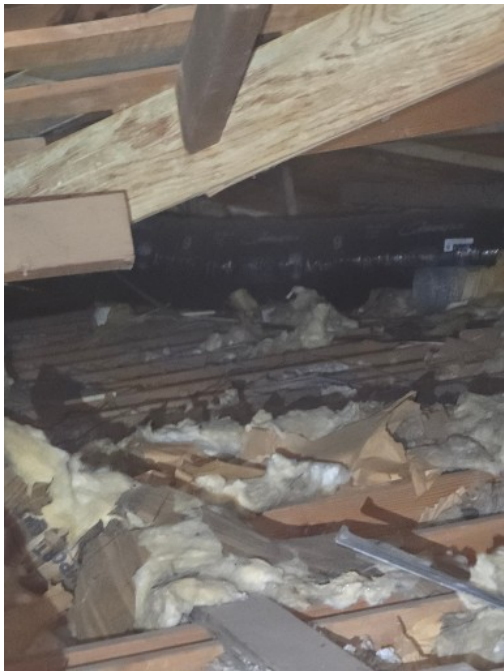
### 3.6) Attic Insulation Conditions

The insulation provided has poor coverage. Additional insulation is recommend.

Observation: Loose wiring and miscellaneous debris observed throughout the attic space.

Implication: Loose wires can pose safety hazards such as electrical shock or fire risk. Debris may indicate past construction work or poor maintenance and could obstruct airflow or present a fire hazard.

Recommend evaluation by a licensed electrician to ensure all wiring is properly secured and safe. Advise removal of debris to maintain a clean and accessible attic space

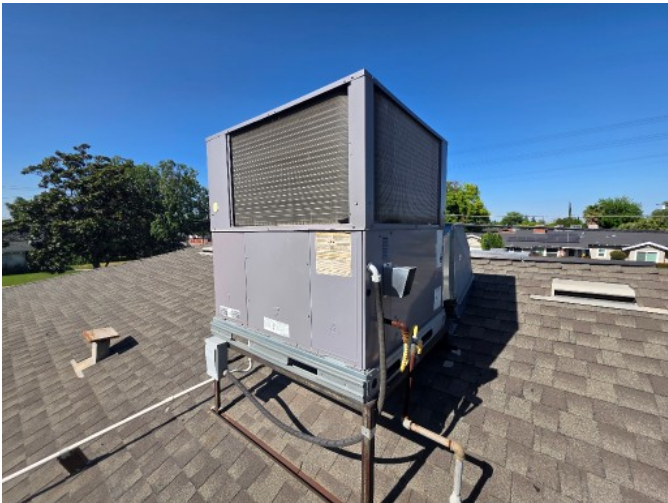
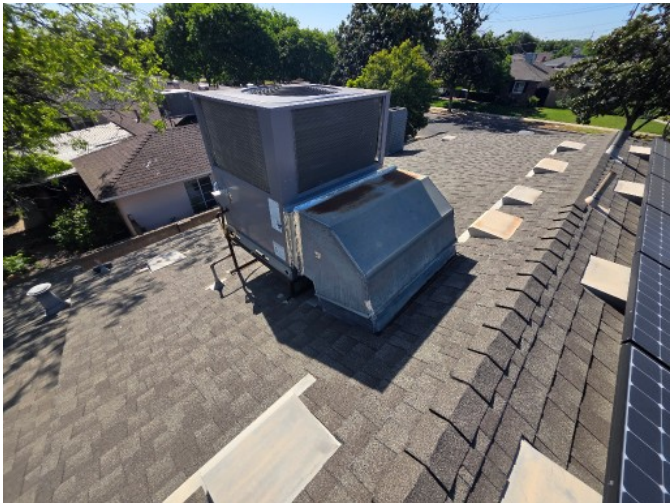
4.1) Unit Conditions

The heating system was operational at the time of inspection. This is not an indication of future operation or condition.  
Recommend burner area be serviced and heat exchanger be examined by a licensed HVAC contractor.

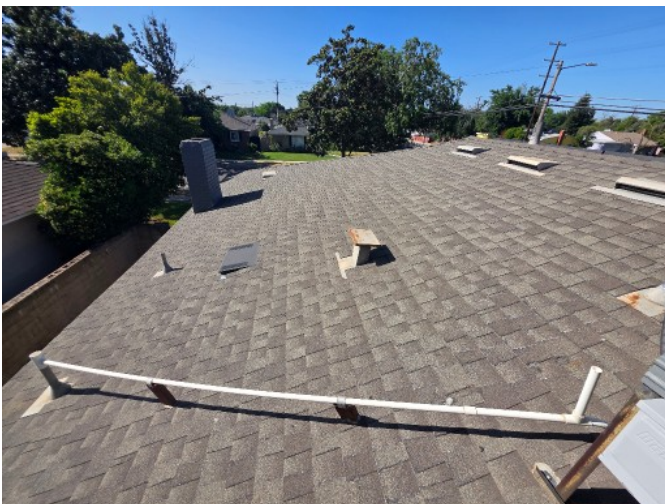
### 4.5) AC Unit Conditions

Appears to be in normal working order at the time of inspection. Recommend extending the condensate water discharge farther away from the house. Looked to be discharging somewhere into the crawl space.

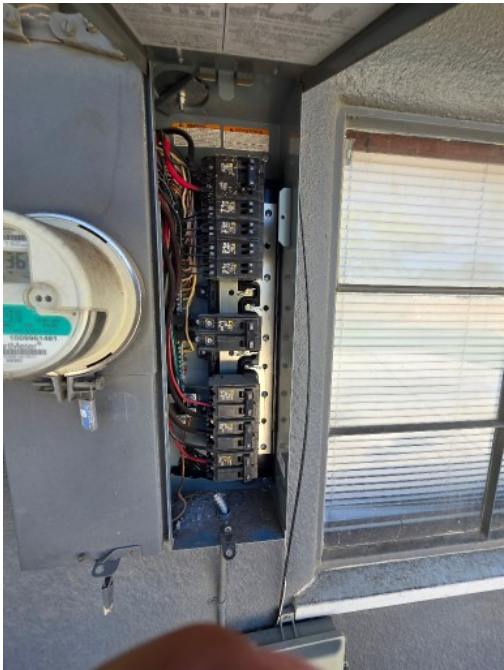
The main panel appeared to be in serviceable condition at the time of the inspection. There was a breaker off at the main panel box. Since tracing of circuits is not performed, recommend verification by an electrician prior to close.

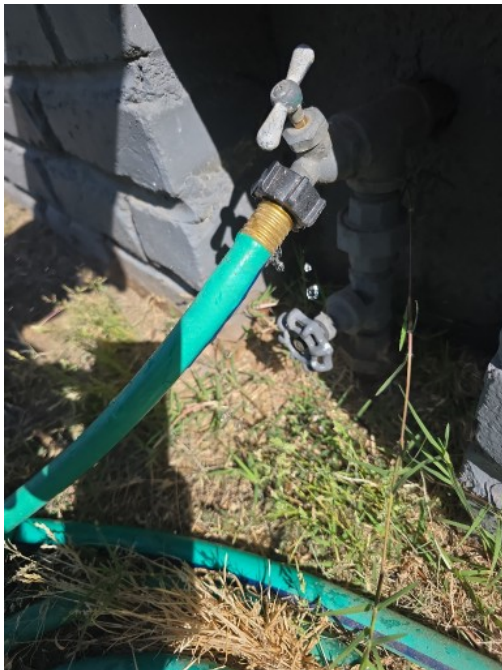
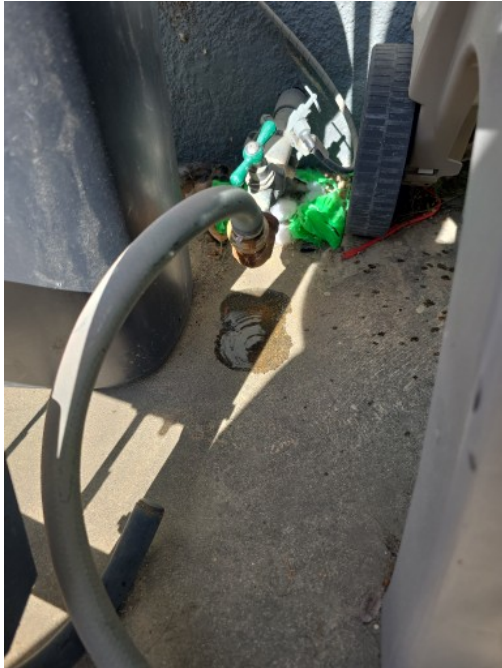
Active leaks were observed at front of the house water house fitting loose. Recommend tightening. The visible portions of the supply lines appeared to be in serviceable condition at the time of inspection. All of the supply lines were not fully visible or accessible at the time of the inspection.

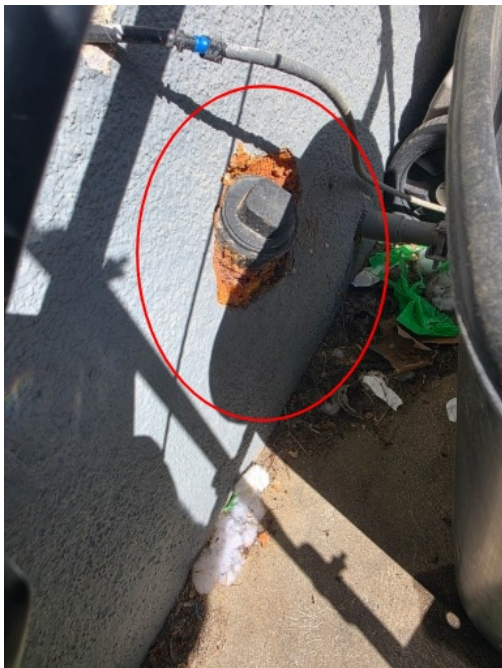
The visible portions of the waste lines appeared to be in serviceable condition at the time of inspection. All of the waste lines were not fully visible or accessible at the time of the inspection.

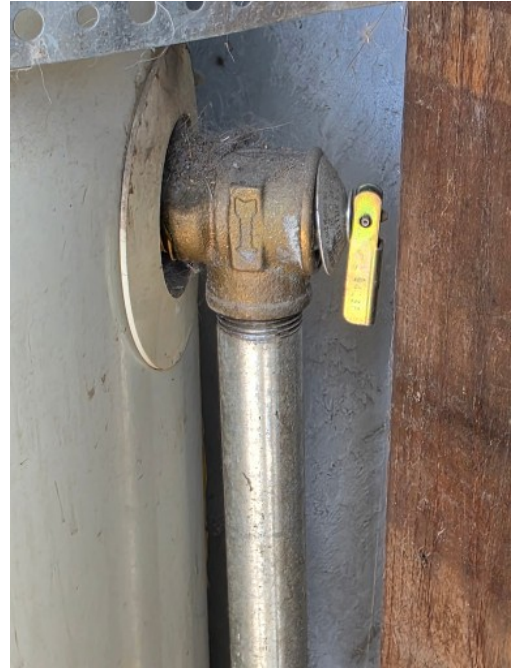
6.4) Water Heater Conditions

The water heater was operable at the time of inspection. This does not however guarantee future performance, operation, or condition.

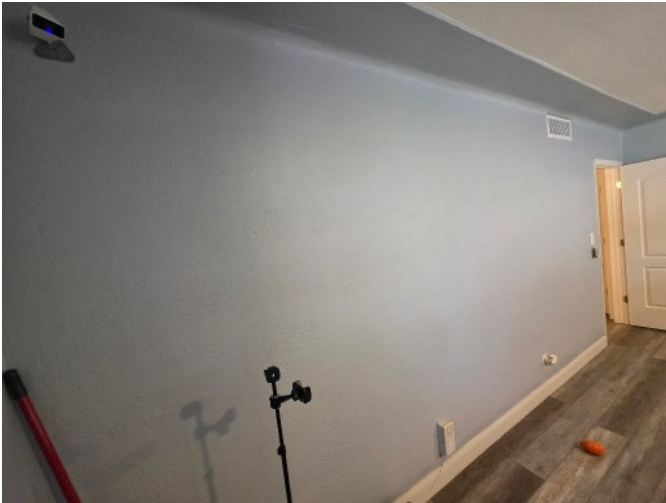
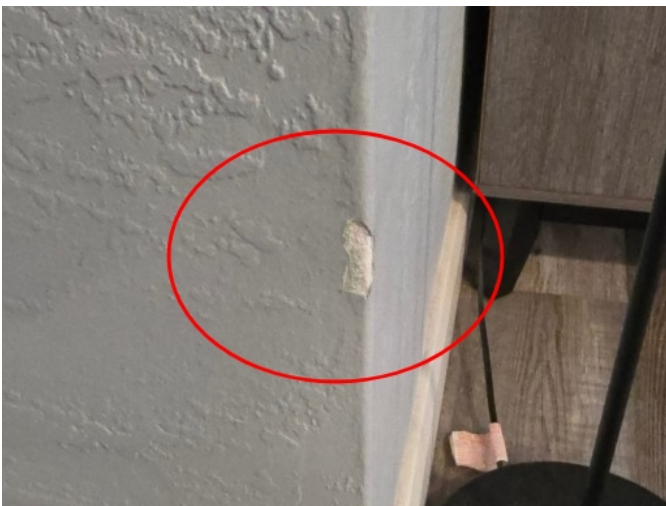
The general condition of the walls appeared to be in serviceable condition at the time of the inspection. The interior walls were damaged at corner heading towards kitchen. Recommend patch and repair.

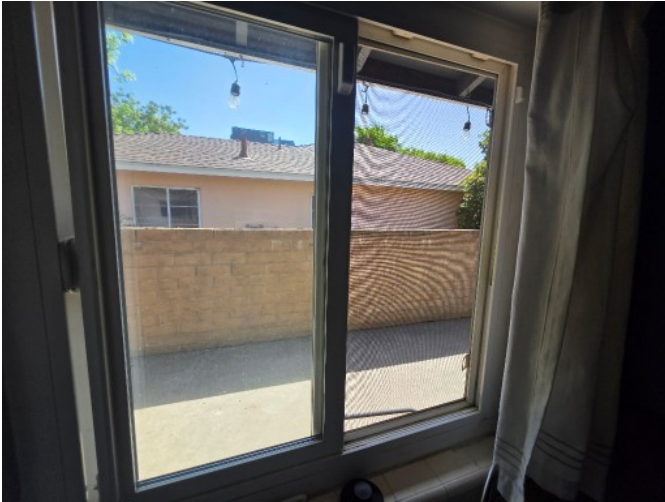
Some windows were difficult to operate. Recommend adjustment and / or repairs as needed. The sample of windows tested were operational at the time of the inspection.

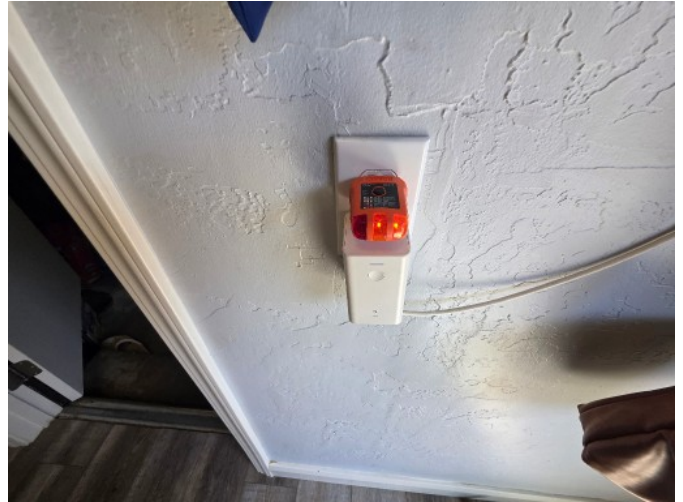
### 7.7) Electrical Conditions

An extension cord was used as permanent wiring at living room. Any time an extension cord is used as part of a circuit it is considered a safety hazard. Recommend further evaluation and / or repair by a licensed electrician prior to close. Exterior motion detector lights or day / night sensors are not tested as part of this inspection. Representative amount of outlets were tested and operational at the time of inspection.

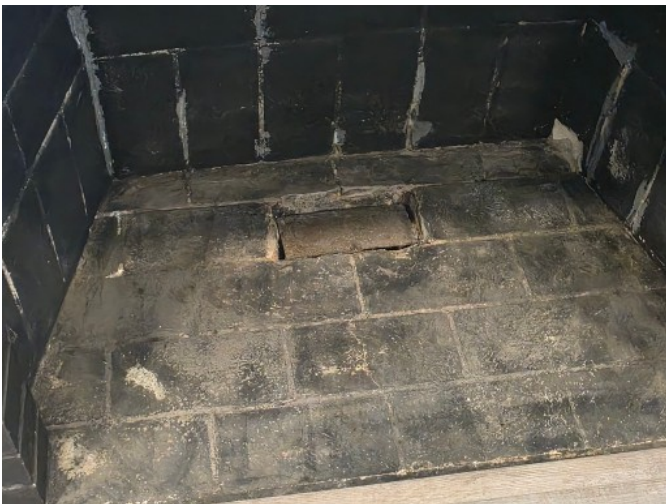
The general condition of the visible and accessible areas of the fireplace appeared to be in serviceable condition at the time of the inspection. Recommend chimney flue cleaning by a chimney sweep specialist. Creosote can accumulate and become a fire hazard if the fireplace and flue are not cleaned regularly.

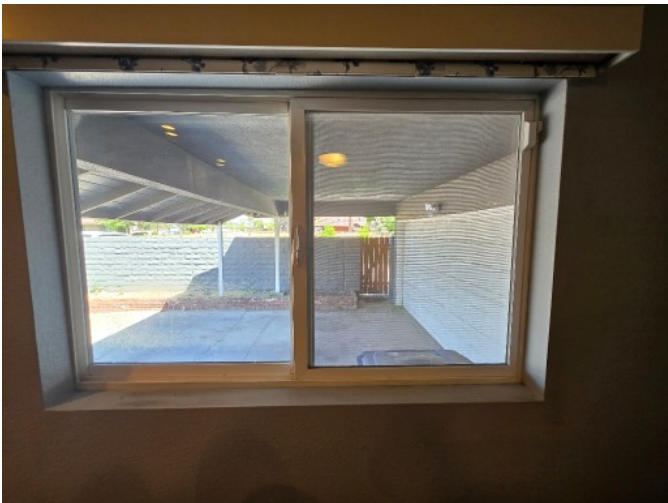
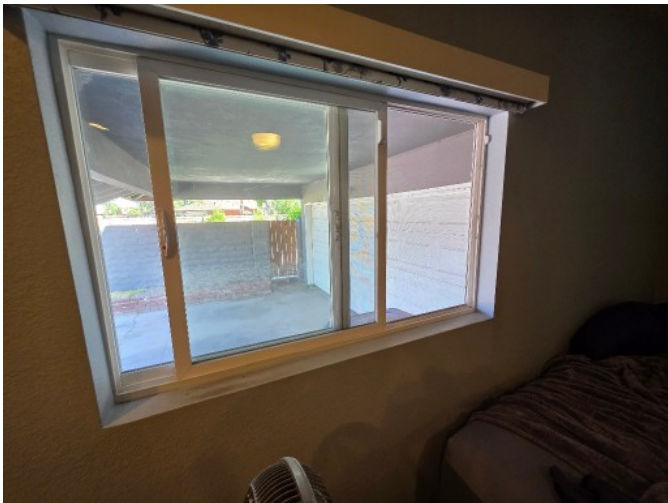
The accessible windows were tested and were operational at the time of the inspection. Some windows were difficult to operate. Recommend adjustment and / or repairs as needed.

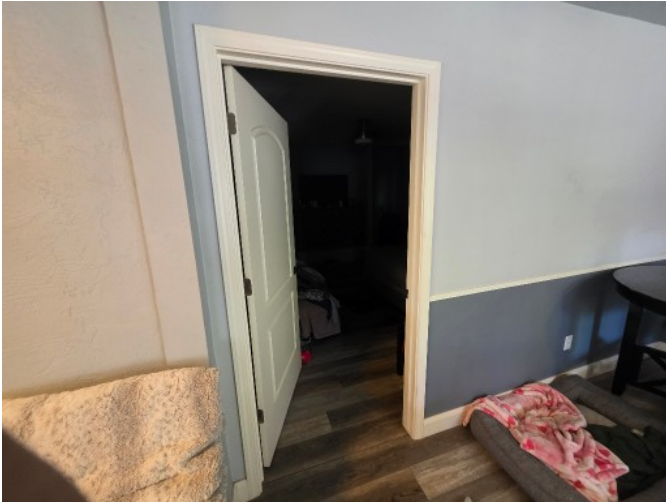
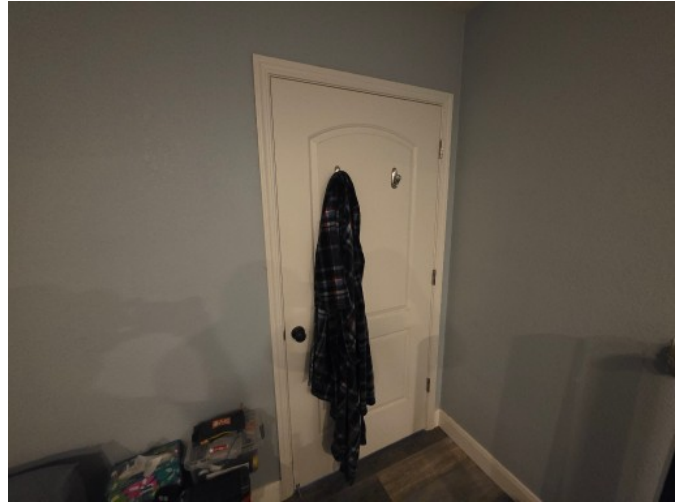
**8.6) Interior Door Conditions**

The interior doors closed and latched at the time of inspection

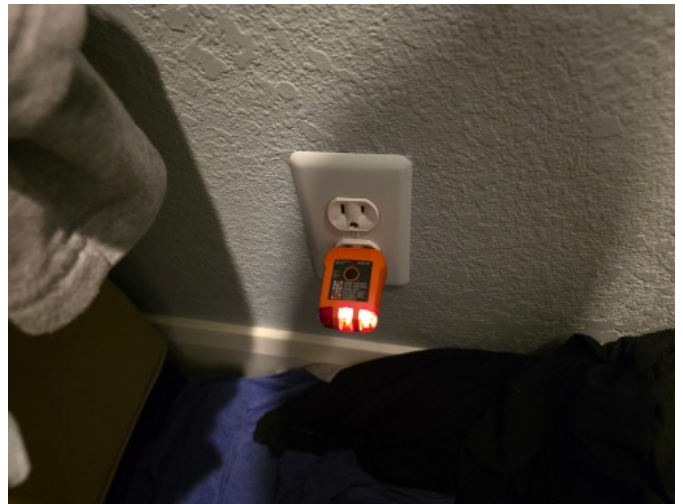
#### 8.7) Electrical Conditions

All accessible outlets were operation and tested for proper wiring at the time of inspection. An extension cord was used as permanent wiring at . Any time an extension cord is used as part of a circuit it is considered a safety hazard. Recommend further evaluation and / or repair by a licensed electrician prior to close. Exterior motion detector lights or day / night sensors are not tested as part of this inspection. Junction or switch box covers were missing at . Recommend installation of covers for increased safety.

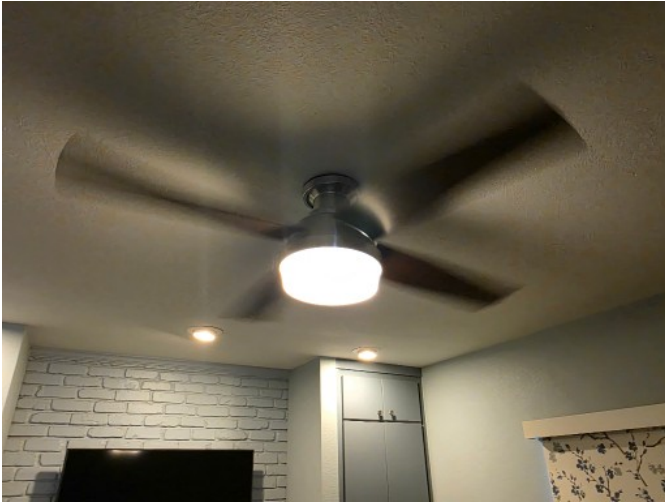
### 8.9) Ceiling Fan Conditions

The ceiling fan(s) were operational at the time of the inspection. Mounting hardware of fans, light fixtures, and / or chandeliers was not visible or accessible for inspection.

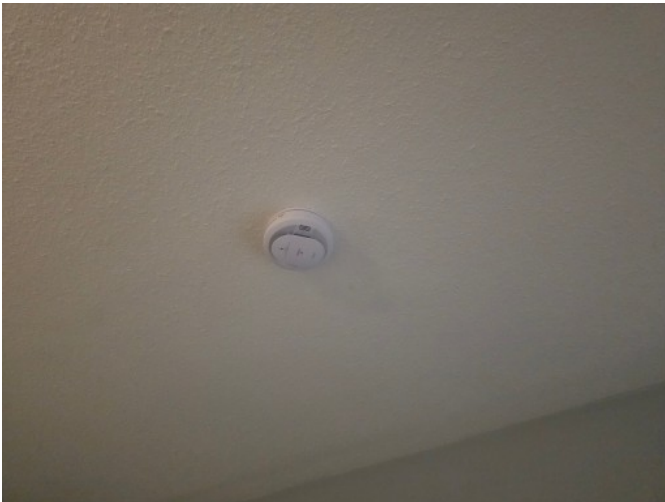
**8.10) Smoke Detector Conditions**

A smoke detector was observed but not tested. The smoke detector may be part of an alarm. The smoke detector was not tested. Smoke detectors have a useful lifespan of about 10 years, it is recommended to replace all units after this time period.

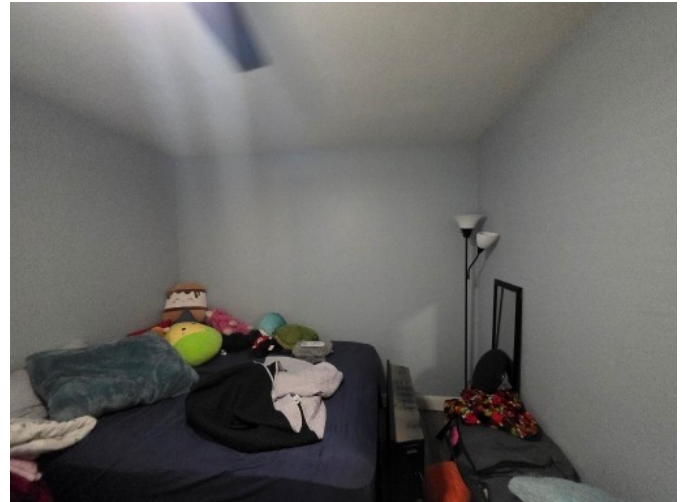
**9 Bedroom 2****Walls - Ceilings - Floors****9.1) Wall Conditions**

The general condition of the walls appeared to be in serviceable condition at the time of the inspection. Furnishings, pictures, wall coverings, and personal item storage prevented a full visual inspection of all areas. Conditions can change between the time of inspection and closing. Client is advised to perform a careful check of all areas during final walk through. Client is advised to note any staining or conditions that may not have been visible during the time of inspection. Such conditions should be brought to your Realtor (if applicable) or Attorney's attention prior to closing of this property.

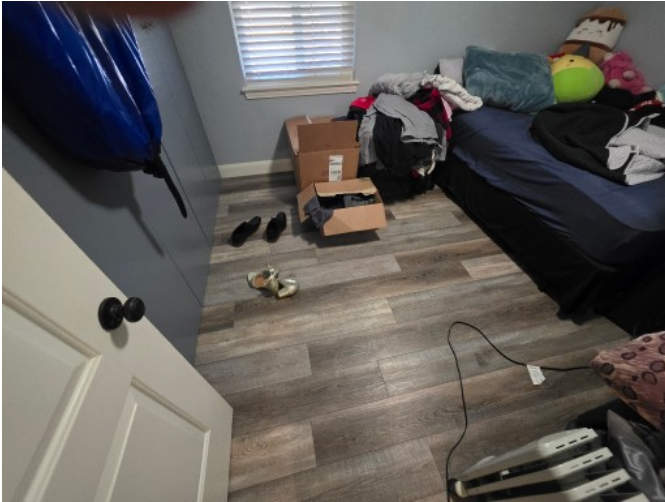
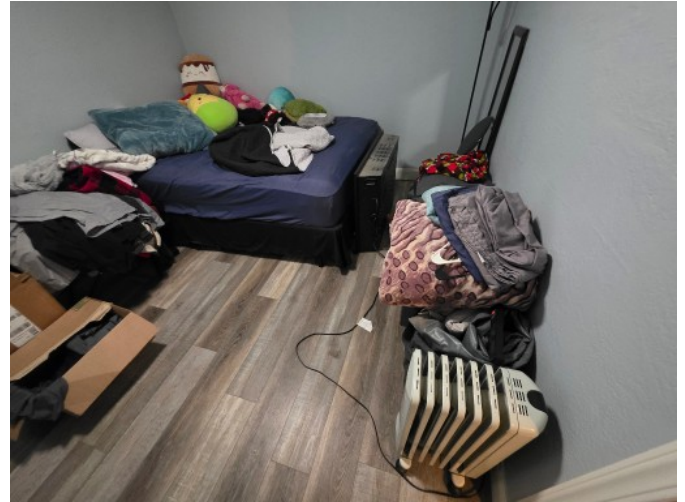
**9.3) Floor Conditions**

The general condition of the visible and accessible portions of the floors appeared to be in serviceable condition at the time of the inspection. Furnishings and personal item storage prevented a full visual inspection of all areas. Conditions can change between the time of inspection and closing. Client is advised to perform a careful check of all areas during final walk-through, including, but not limited to, any staining, floor sloping, squeaking / movement or adverse conditions that may not have been visible or accessible during the time of original inspection. Such conditions should be brought to the attention of your Realtor (if applicable) or Attorney prior to closing of this property.

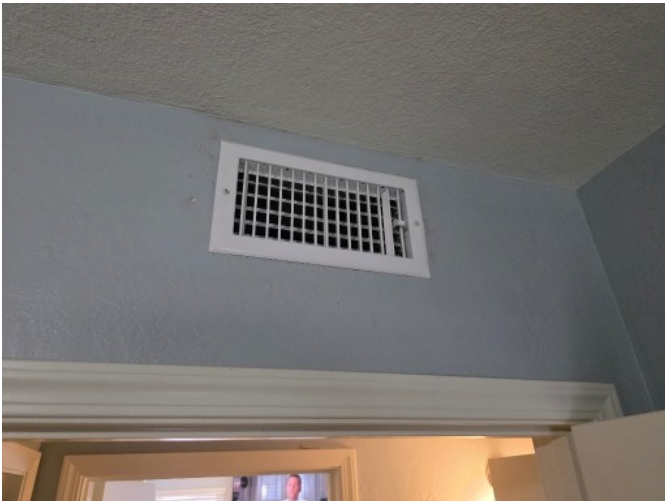
**9.4) Heat Source Conditions**

Appears Serviceable.

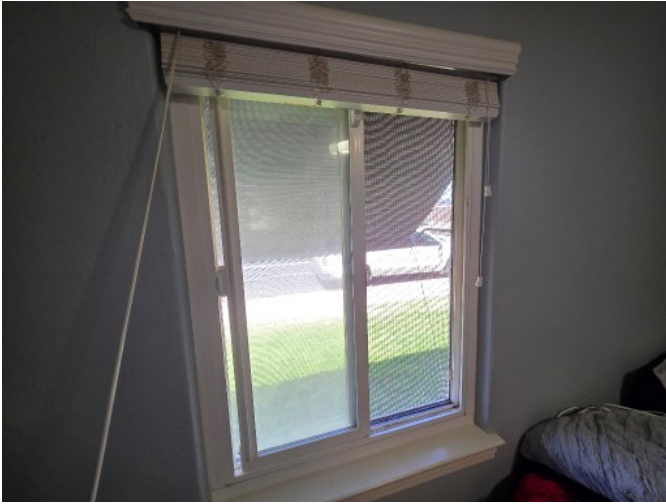
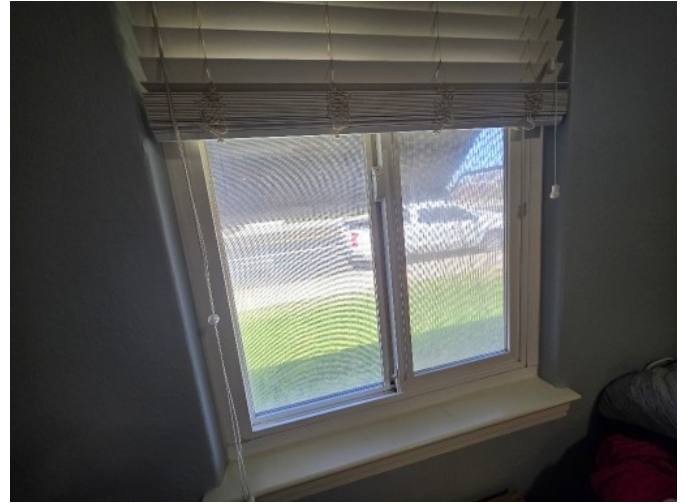
**Windows - Doors****9.5) Interior Window Conditions**

The sample of windows tested were operational at the time of the inspection. Some windows were difficult to operate. Recommend adjustment and / or repairs as needed.
