# Inspection Report

**VALUE GUARANTEED INSPECTIONS**

1234 W Filmore Ave

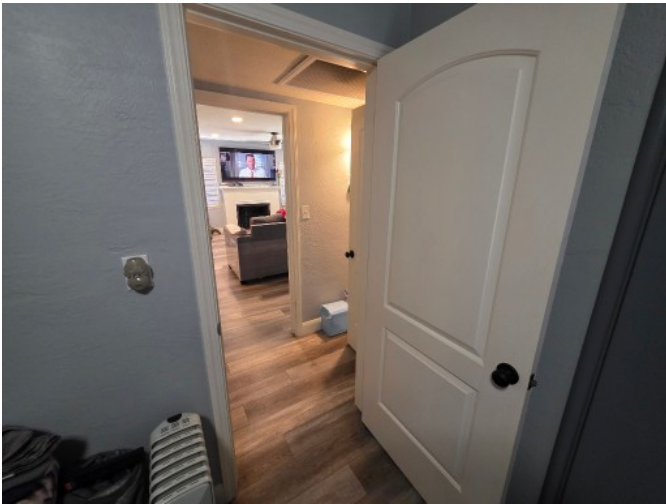
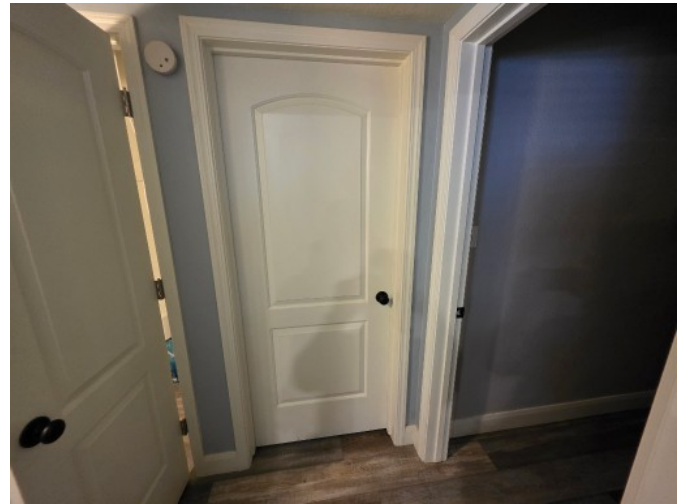
**9.6) Interior Door Conditions**

The interior doors appeared to be in serviceable condition at the time of the inspection.

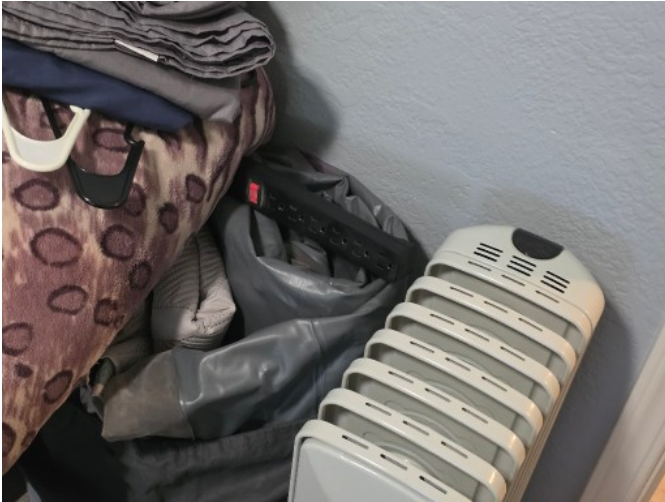
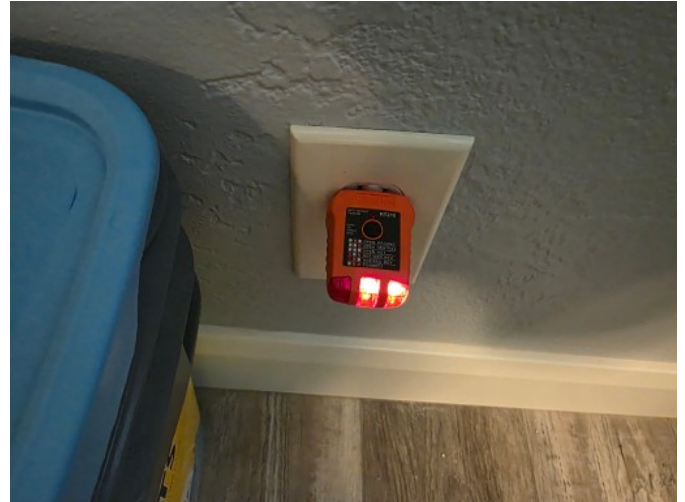
**Electrical Conditions****9.7) Electrical Conditions**

An extension cord was used as permanent wiring at bedroom 2. Any time an extension cord is used as part of a circuit it is considered a safety hazard. Recommend further evaluation and / or repair by a licensed electrician prior to close. Exterior motion detector lights or day / night sensors are not tested as part of this inspection. Personal items blocking some of the outlets around room. Outlets accessible were tested and operational at the time of inspection.

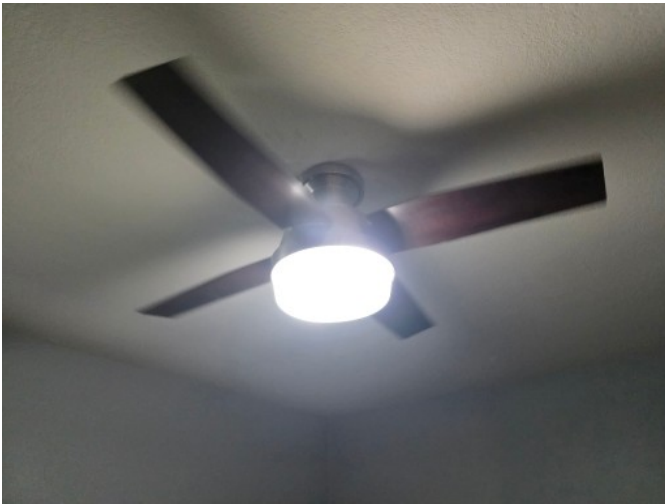
#### 9.8) Lighting Conditions

Appears Serviceable.

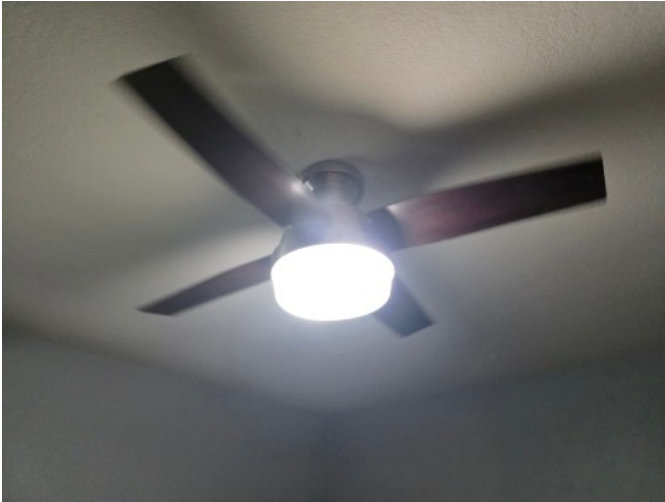
#### 9.9) Ceiling Fan Conditions

Appears Serviceable. The ceiling fan(s) were operational at the time of the inspection. Mounting hardware of fans, light fixtures, and / or chandeliers was not visible or accessible for inspection.

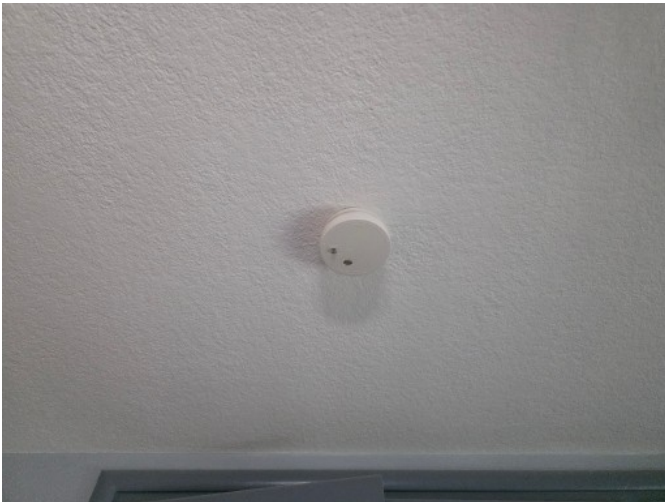
**9.10) Smoke Detector Conditions**

The smoke detector may be part of an alarm. The smoke detector was not tested. Smoke detectors have a useful lifespan of about 10 years, it is recommended to replace all units after this time period.

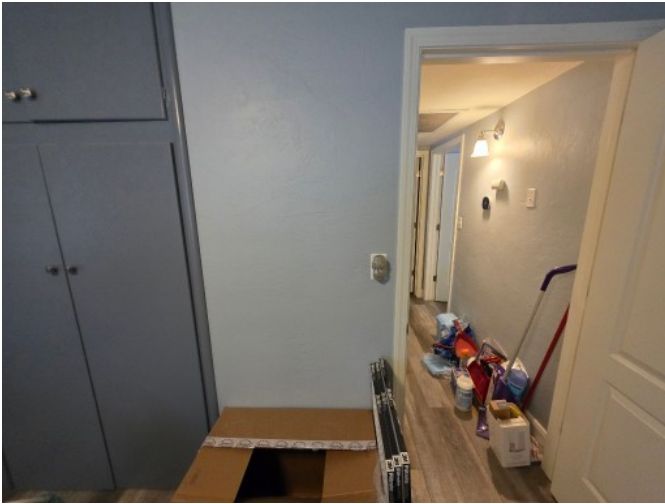
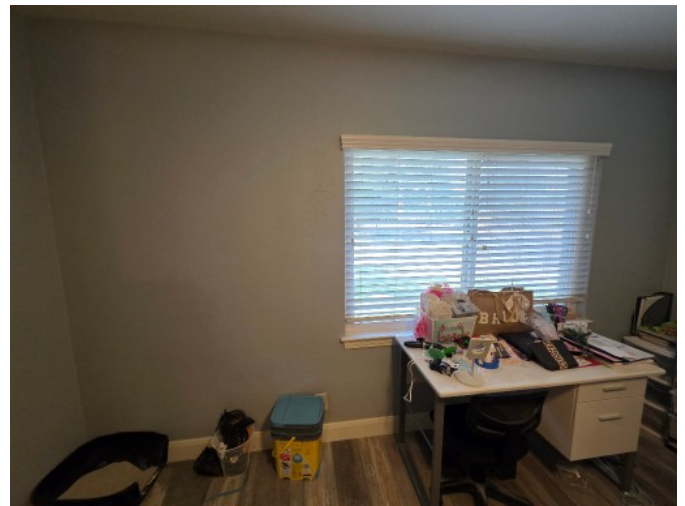
#### 10.1) Wall Conditions

The general condition of the walls appeared to be in serviceable condition at the time of the inspection. Furnishings, pictures, wall coverings, and personal item storage prevented a full visual inspection of all areas. Conditions can change between the time of inspection and closing. Client is advised to perform a careful check of all areas during final walk through. Client is advised to note any staining or conditions that may not have been visible during the time of inspection. Such conditions should be brought to your Realtor (if applicable) or Attorney's attention prior to closing of this property.

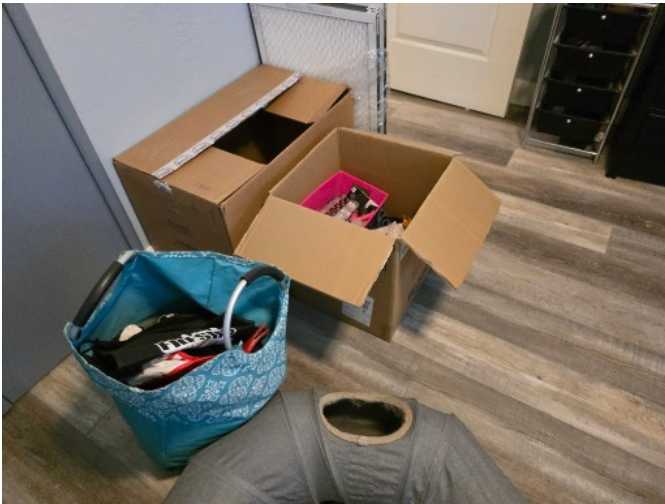
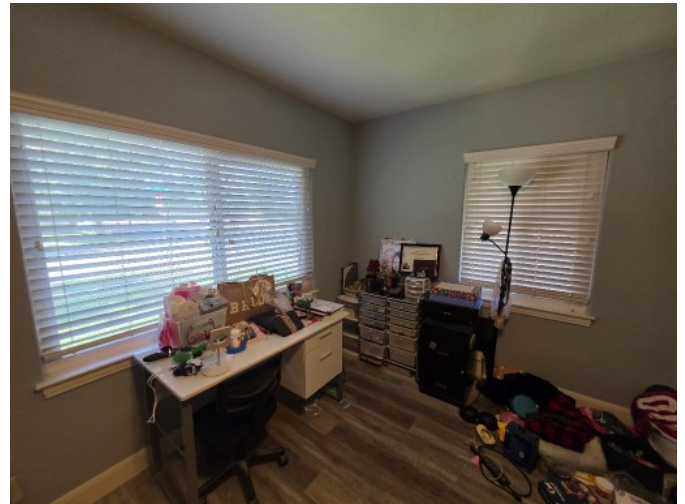
**10.3) Floor Conditions**

The general condition of the visible and accessible portions of the floors appeared to be in serviceable condition at the time of the inspection. Furnishings and personal item storage prevented a full visual inspection of all areas. Conditions can change between the time of inspection and closing. Client is advised to perform a careful check of all areas during final walk-through, including, but not limited to, any staining, floor sloping, squeaking / movement or adverse conditions that may not have been visible or accessible during the time of original inspection. Such conditions should be brought to the attention of your Realtor (if applicable) or Attorney prior to closing of this property.

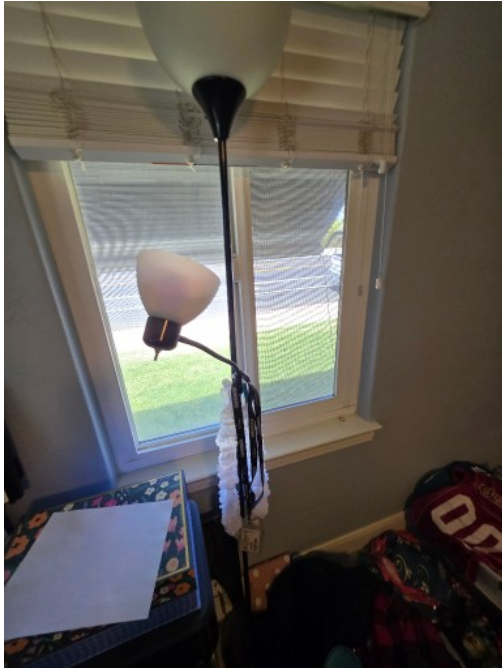
### 10.5) Interior Window Conditions

The sample of windows tested were operational at the time of the inspection. Some windows were difficult to operate. Recommend adjustment and / or repairs as needed.

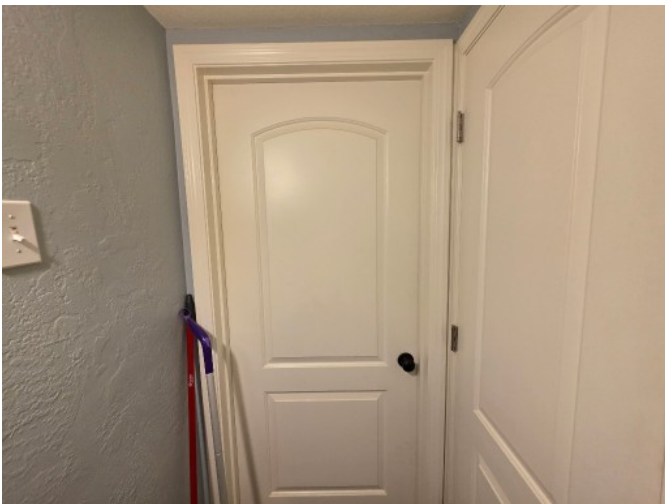
**10.6) Interior Door Conditions**

The interior doors appeared to be in serviceable condition at the time of the inspection.

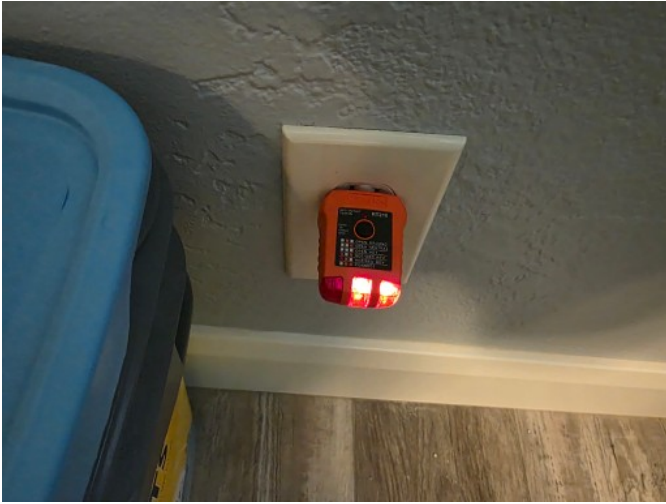
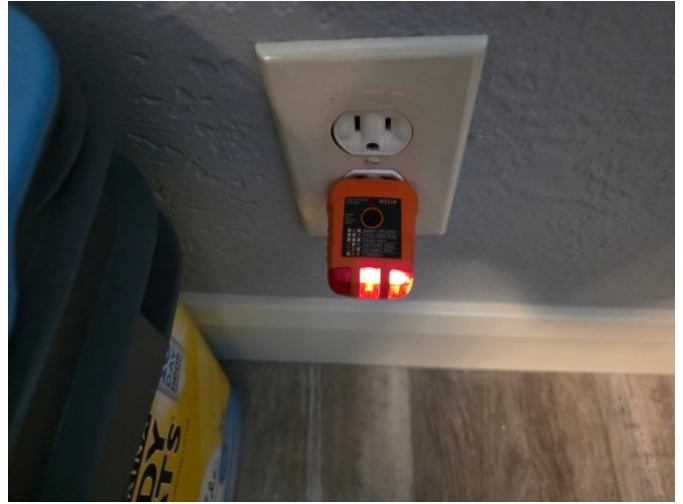
**Electrical Conditions****10.7) Electrical Conditions**

All outlets tested appeared to be in serviceable condition at the time of inspection. An extension cord was used as permanent wiring at . Any time an extension cord is used as part of a circuit it is considered a safety hazard. Recommend further evaluation and / or repair by a licensed electrician prior to close. Exterior motion detector lights or day / night sensors are not tested as part of this inspection. Some outlets were covered or had personal items plugged into, outlets that were accessible at the time of inspection were operational.

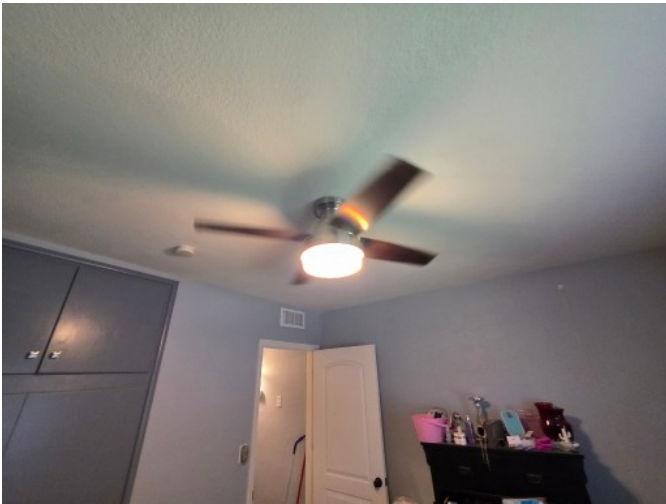
### 10.8) Lighting Conditions

Lighting conditions appeared to be in serviceable condition at the time of inspection.

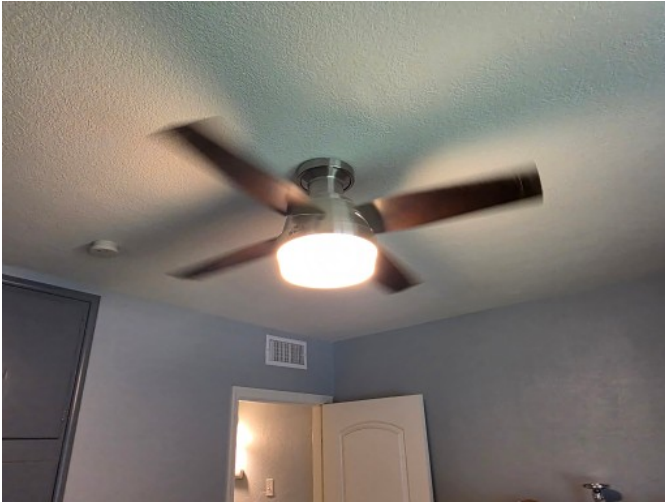
### 10.9) Ceiling Fan Conditions

The ceiling fan(s) were operational at the time of the inspection. Mounting hardware of fans, light fixtures, and / or chandeliers was not visible or accessible for inspection.

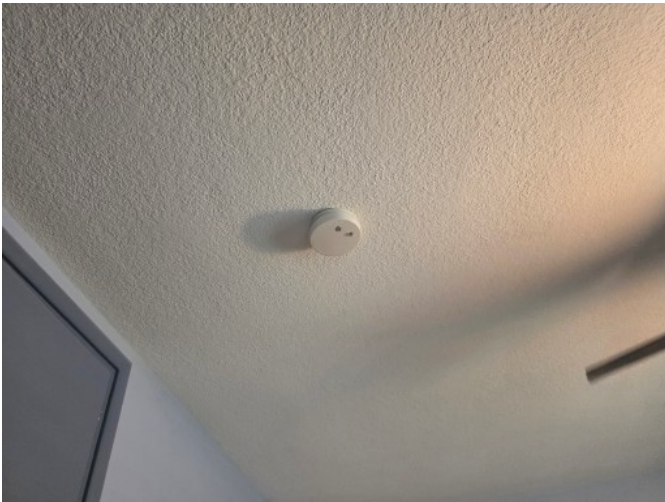
**10.10) Smoke Detector Conditions**

The smoke detector may be part of an alarm. The smoke detector was not tested. Smoke detectors have a useful lifespan of about 10 years, it is recommended to replace all units after this time period.

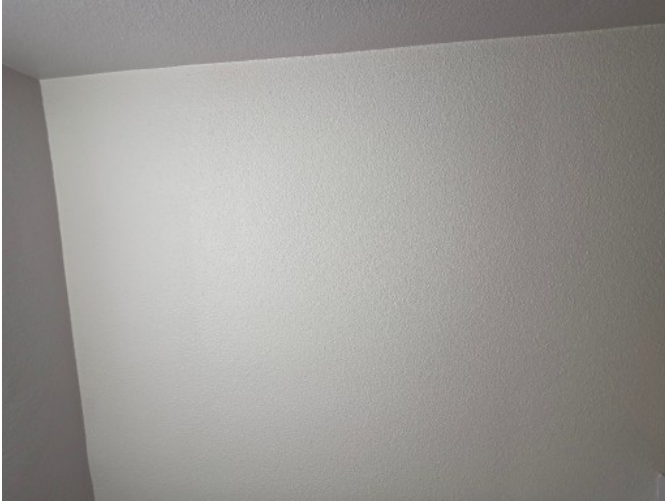
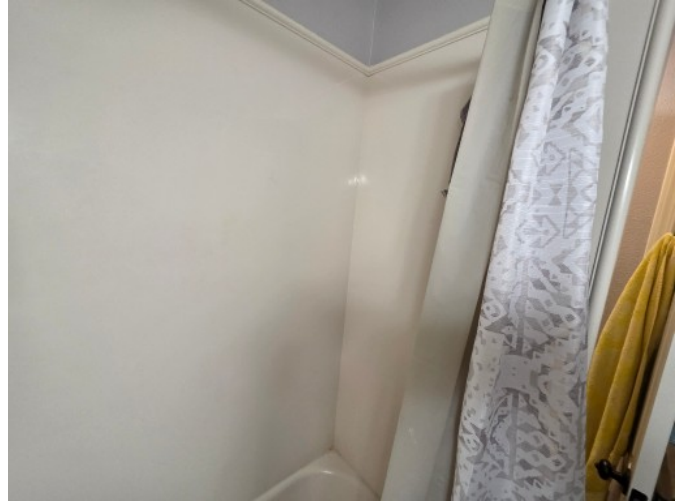
**11 Bathroom 1****Walls - Ceilings - Floors****11.1) Wall Conditions**

The general condition of the walls appeared to be in serviceable condition at the time of the inspection.

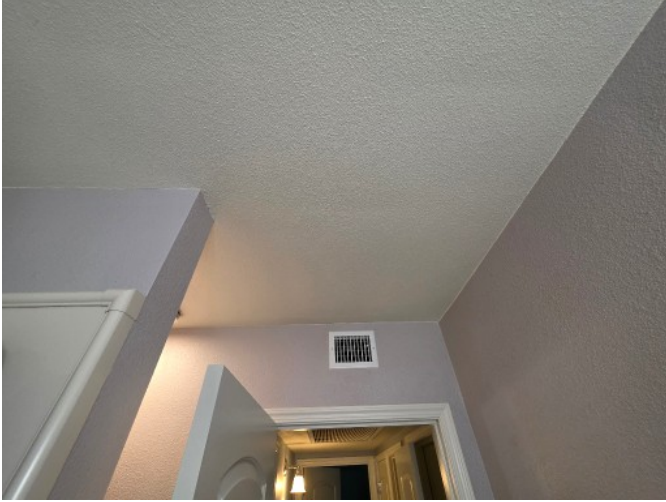
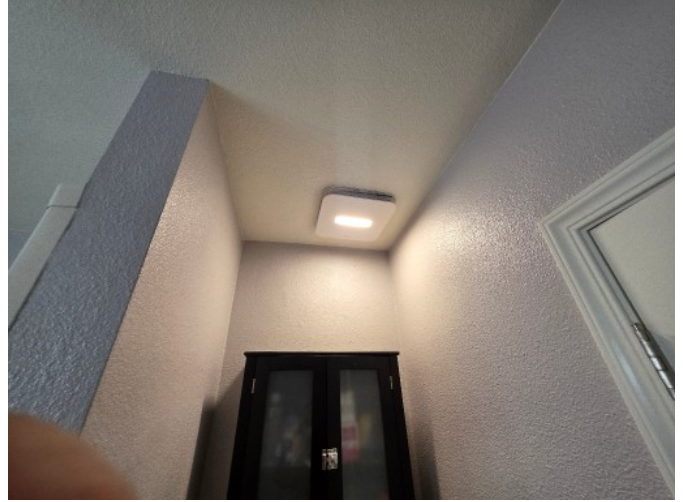
**11.2) Ceiling Conditions**

The general condition of the ceilings appeared to be in serviceable condition at the time of the inspection.

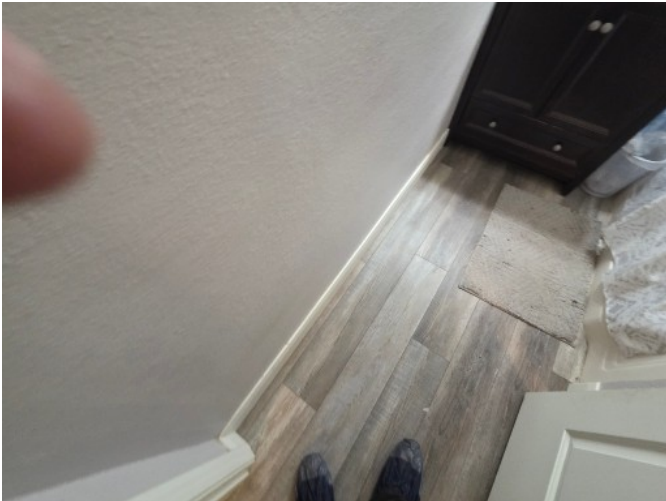
### 11.3) Floor Conditions

The general condition of the visible and accessible portions of the floors appeared to be in serviceable condition at the time of the inspection.

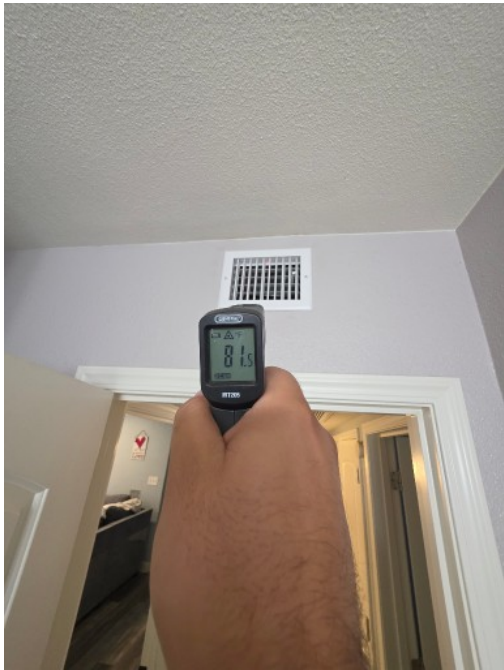
### 11.4) Heat Source Conditions

Appears Serviceable.

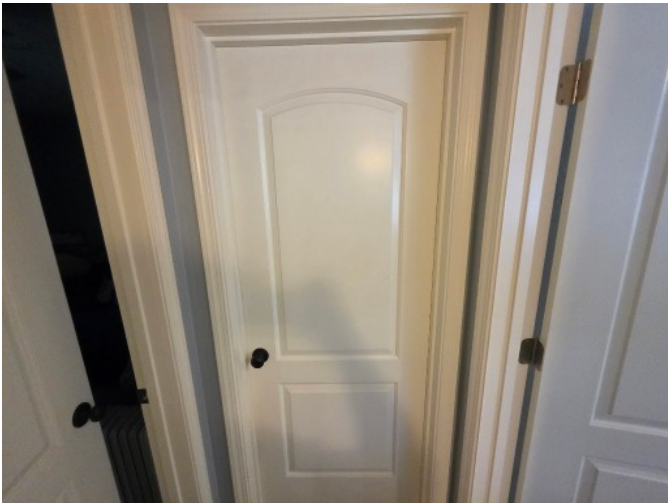
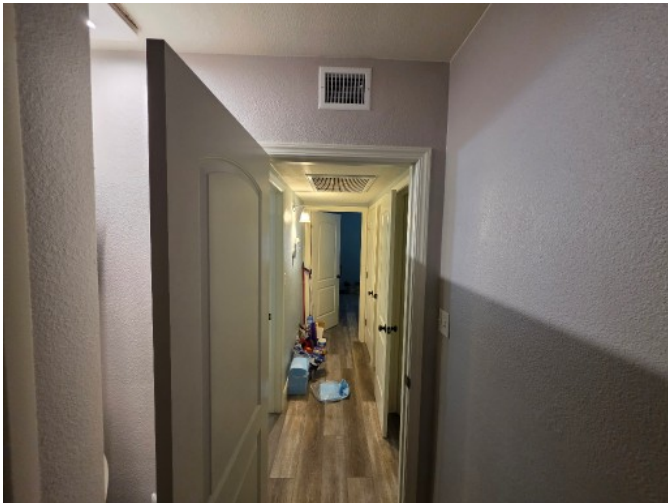
**11.6) Bathroom Door Conditions** AS

The interior doors appeared to be in serviceable condition at the time of the inspection.

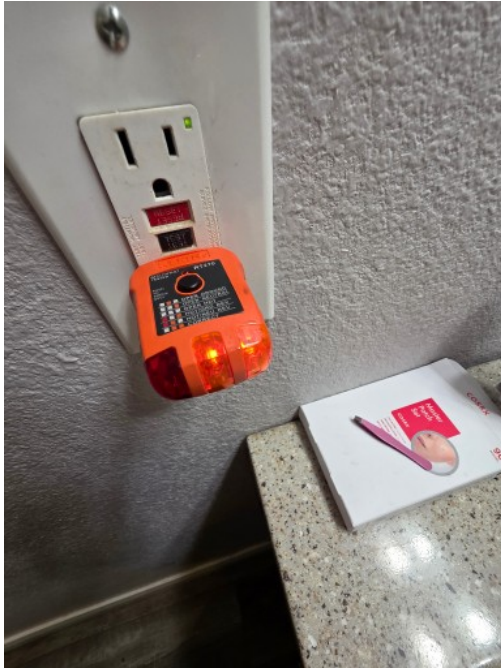
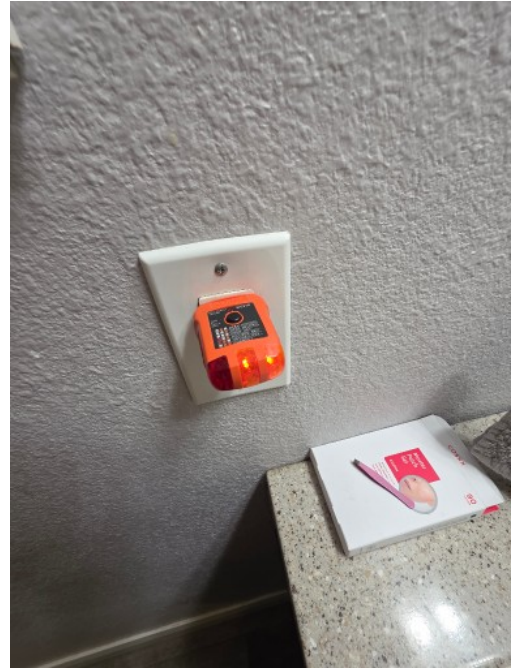
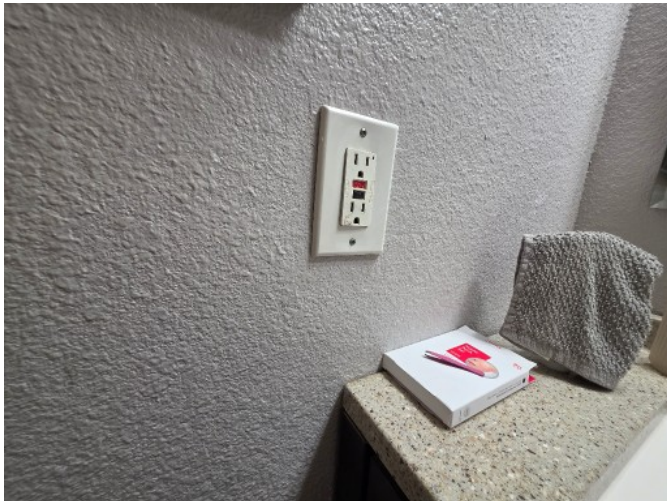
**11.7) Electrical Conditions** AS

Appears Serviceable.

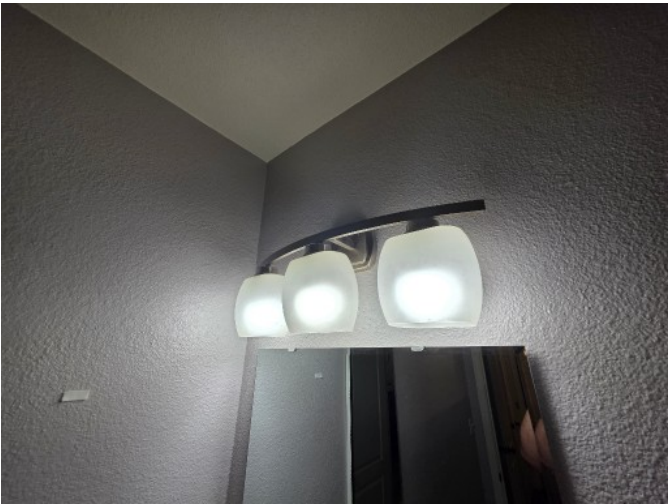
#### 11.8) Lighting Conditions

Appears Serviceable.

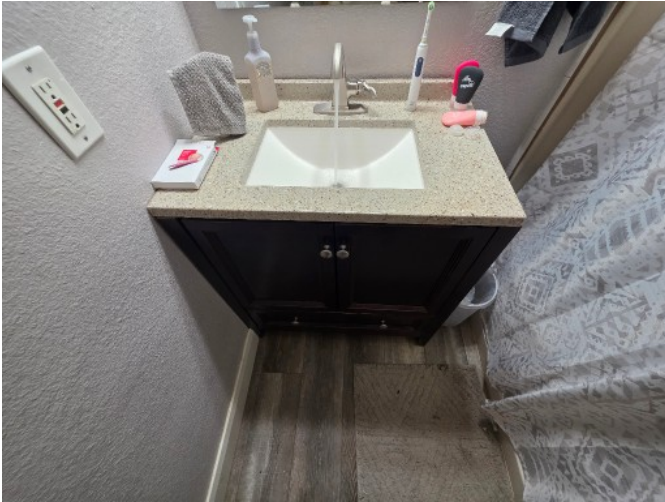
Appears Serviceable.

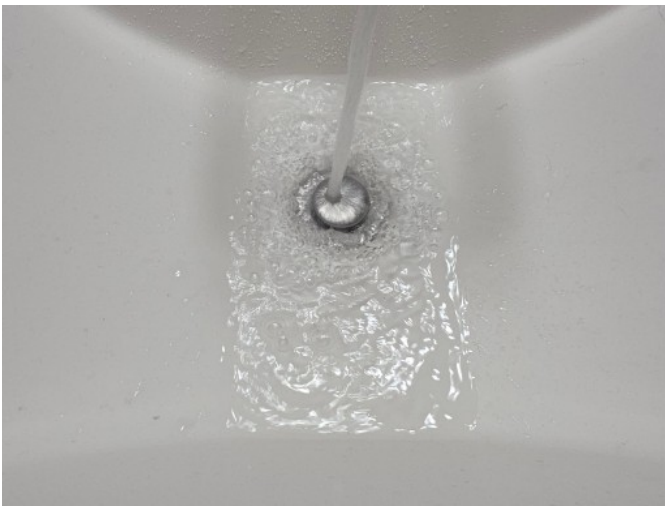
**11.11) Sink Conditions**

The sink appeared to be in serviceable condition at the time of inspection in bath. An "S" type trap was observed as part of the sink drain in bath. Although these types of traps were common at the time of installation, replacement of the older "S" trap with the common "P" trap may be needed. The older plumbing may not be vented in accordance with today's standards. Client should consult a plumber for additional information. The sink drain stopper did not operate or was missing in bath.

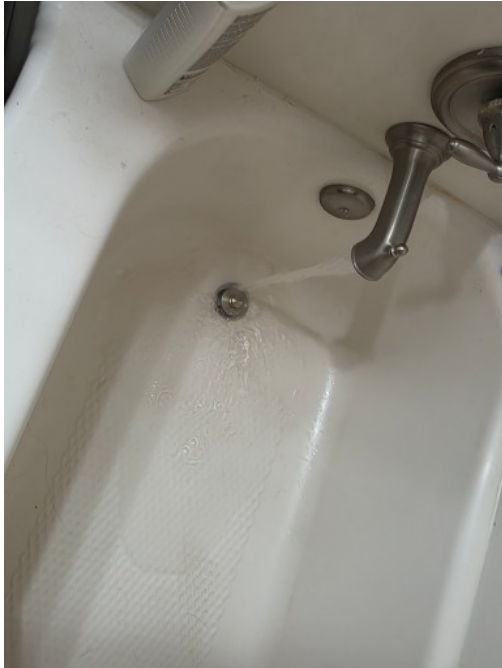
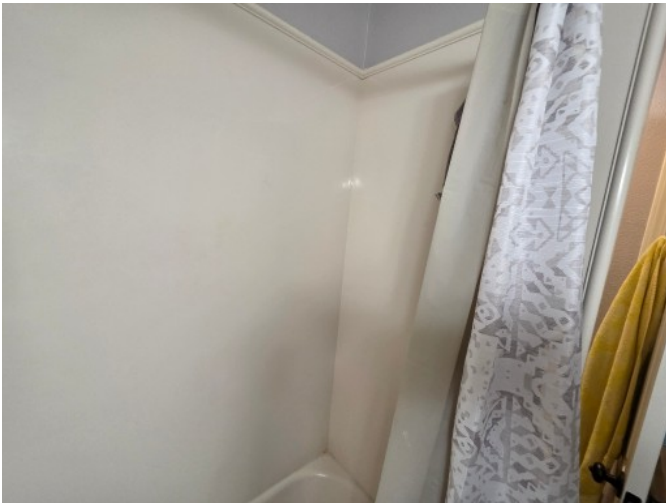
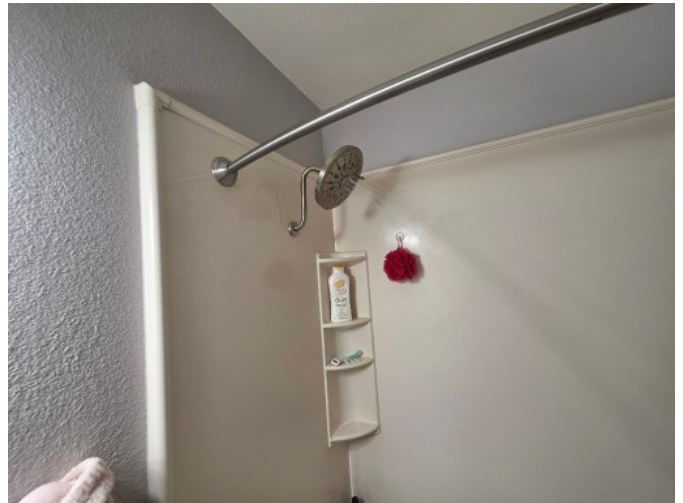
**Shower - Tub - Toilet****11.12) Shower - Tub Conditions**

The bathtub, faucet, and drains appeared to be in serviceable condition. Caulking is recommended at the tub walls and or floors in bath. Conditions behind wall or under floor were concealed and not visible or accessible for inspection.

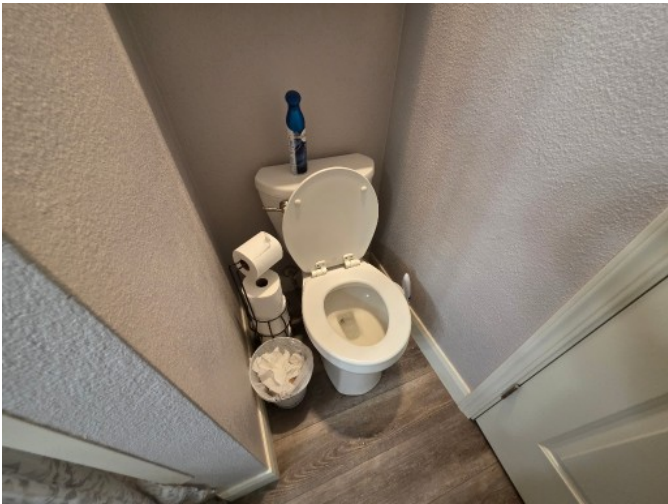
### 11.13) Toilet Conditions

The toilet appeared to be in serviceable condition at the time of inspection in bath.

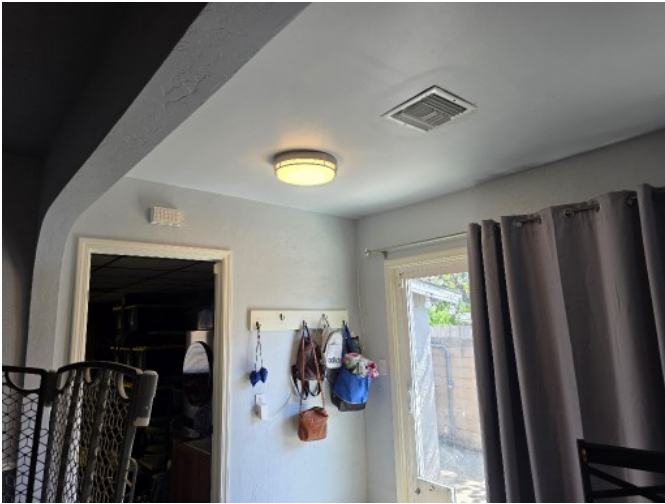
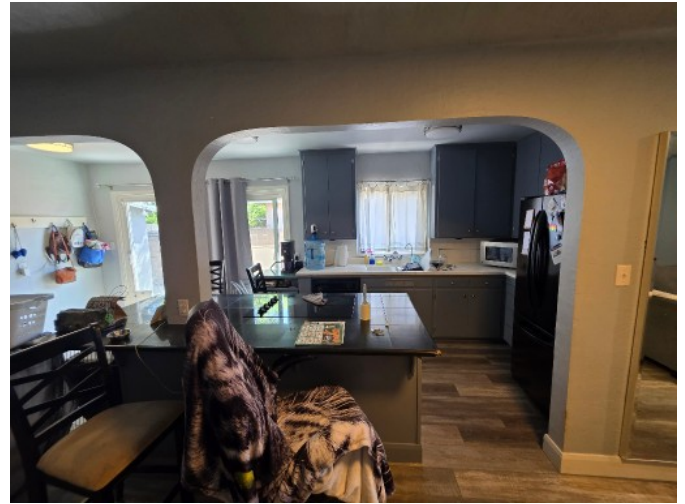
**12.2) Ceiling Conditions**

The general condition of the walls appeared to be in serviceable condition at the time of the inspection. Furnishings, pictures, wall coverings, and personal item storage prevented a full visual inspection of all areas. Conditions can change between the time of inspection and closing. Client is advised to perform a careful check of all areas during final walk through. Client is advised to note any staining or conditions that may not have been visible during the time of inspection. Such conditions should be brought to your Realtor (if applicable) or Attorney's attention prior to closing of this property.

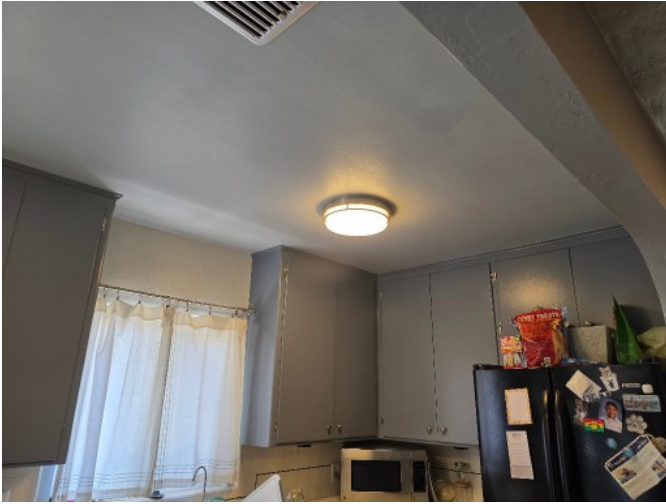
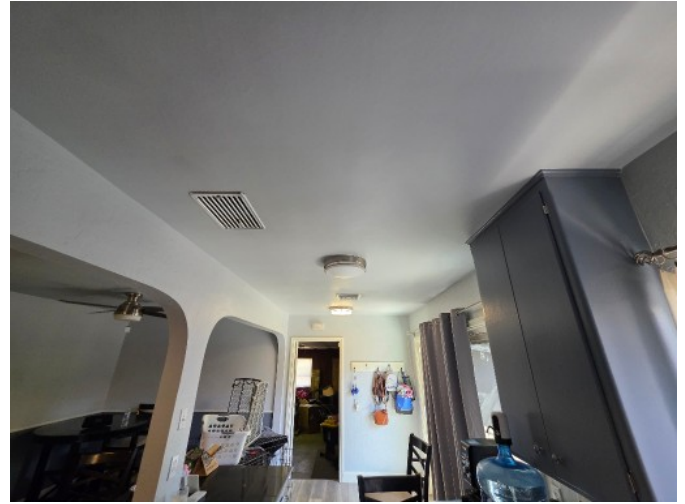
The general condition of the ceilings appeared to be in serviceable condition at the time of the inspection.

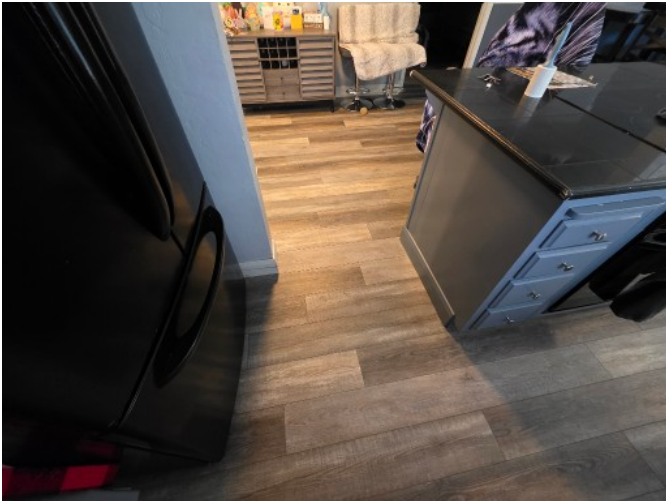
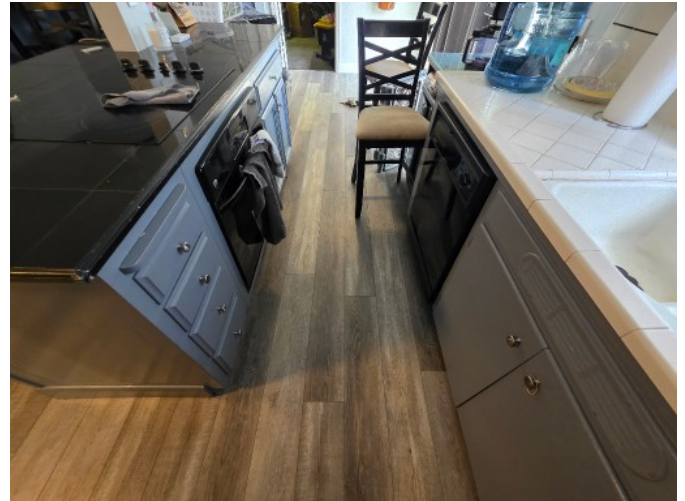
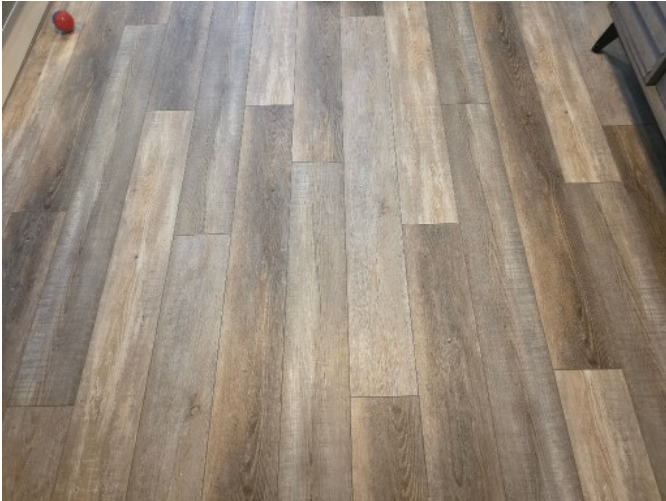
### 12.3) Floor Conditions

The general condition of the visible and accessible portions of the floors appeared to be in serviceable condition at the time of the inspection.

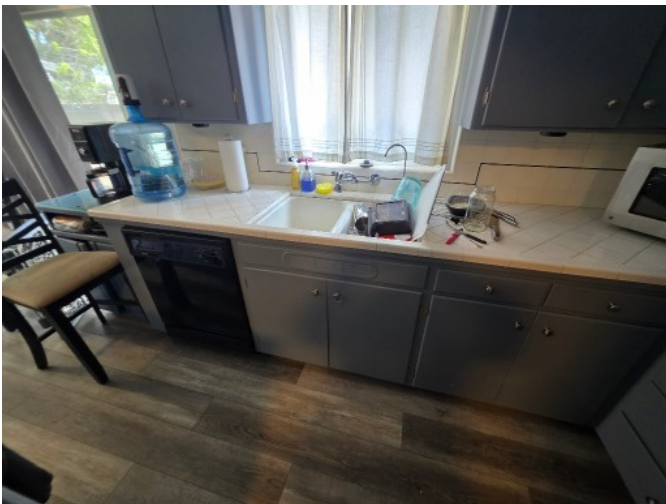
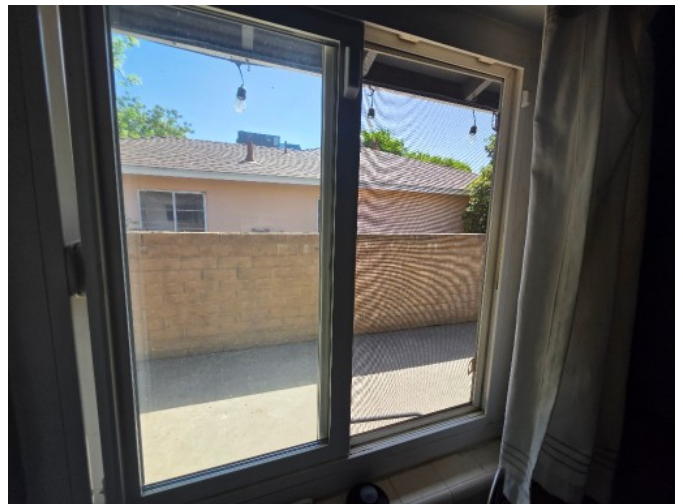
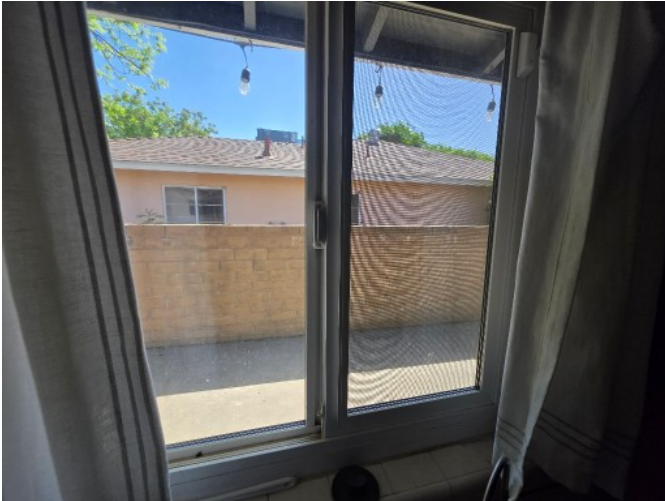
**12.5) Kitchen Window Conditions**

The sample of windows tested were operational at the time of the inspection. Some windows were difficult to operate. Recommend adjustment and / or repairs as needed.

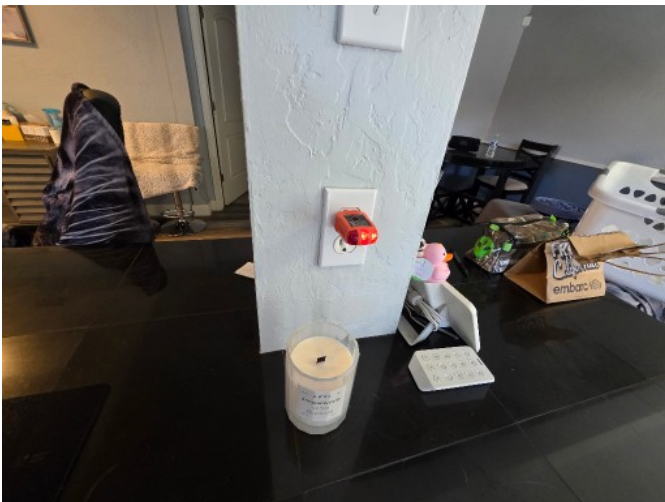
### 12.7) Electrical Conditions

Appears Serviceable. Minimal outlets were observed. Recommend adding outlets to reduce extension cord usage and to increase safety.

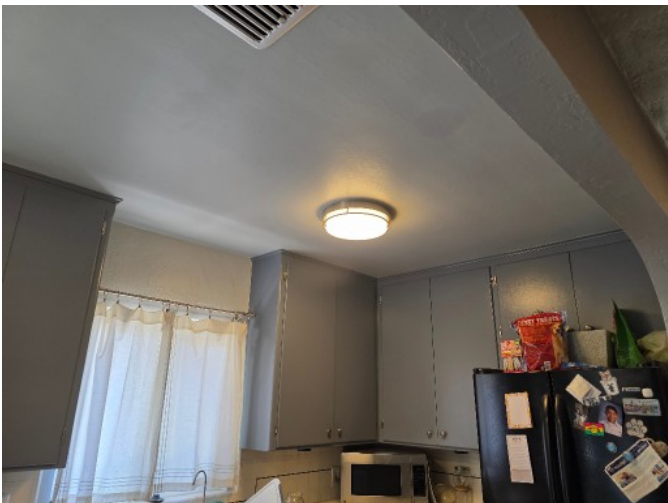
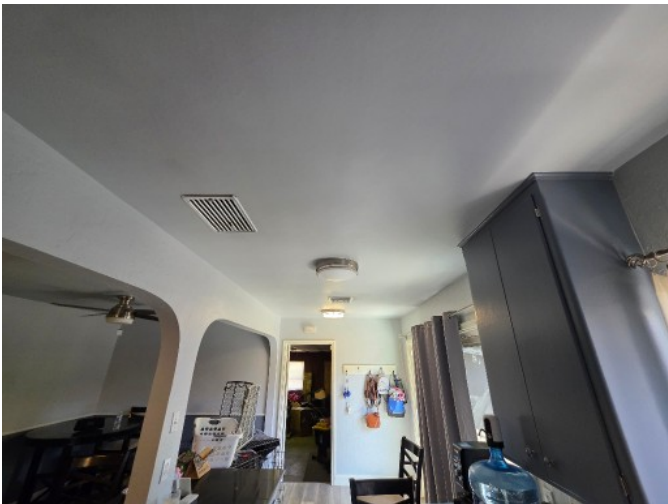
12.8) Lighting Conditions

Appears Serviceable.

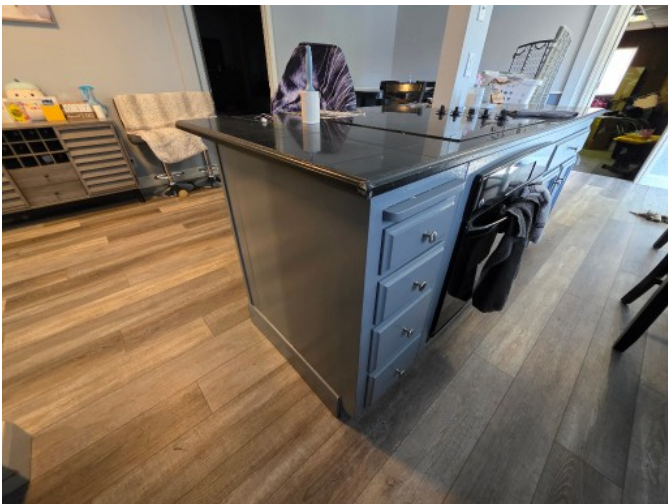
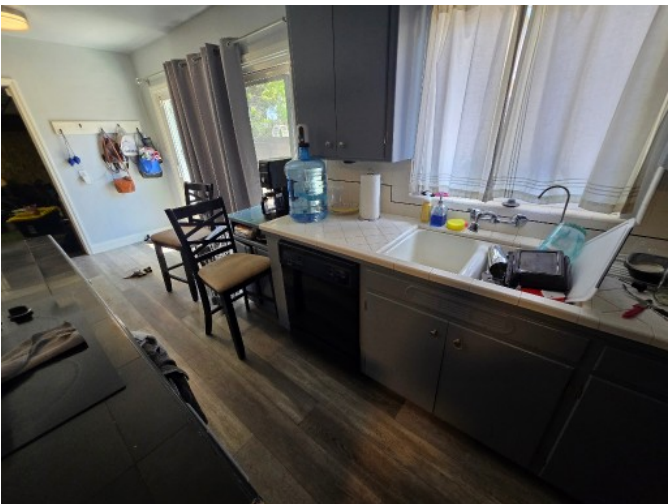
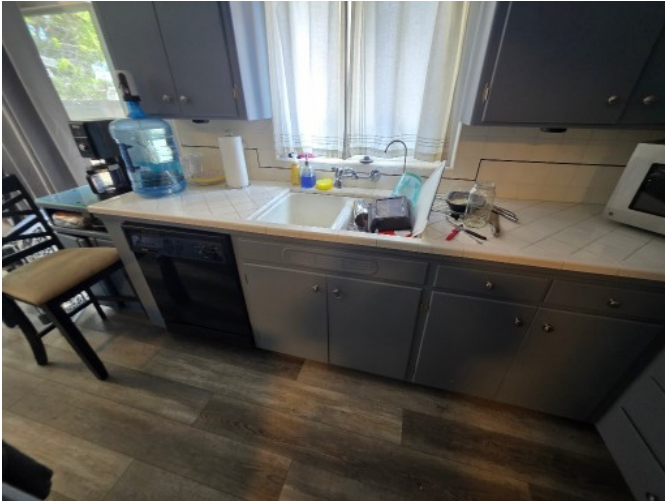
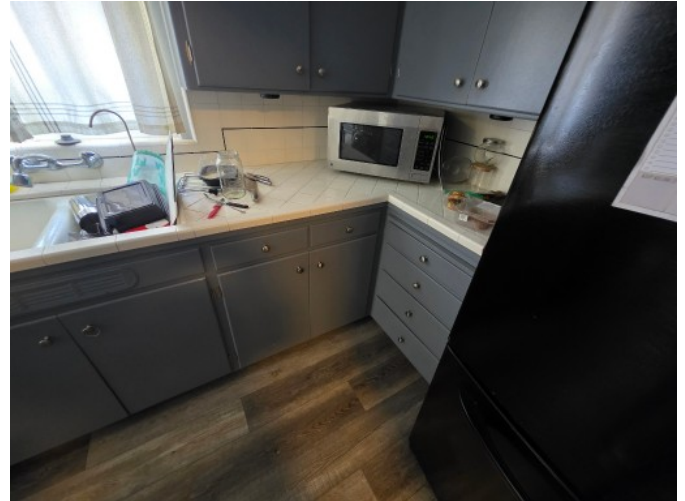
12.10) Counter Conditions

The visible portion kitchen counters appeared to be in serviceable condition at the time of the inspection.

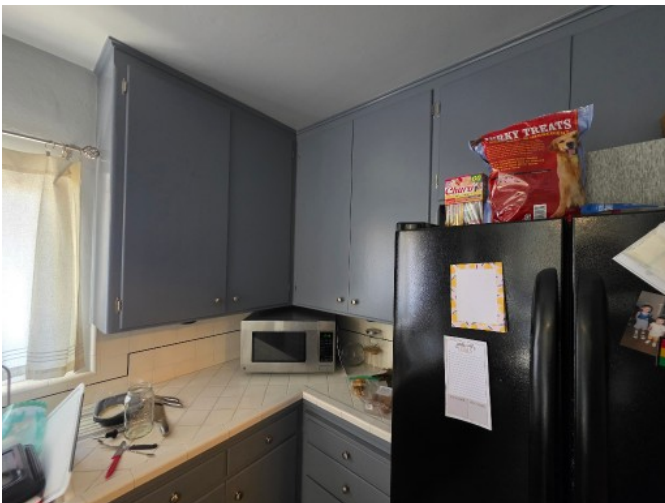
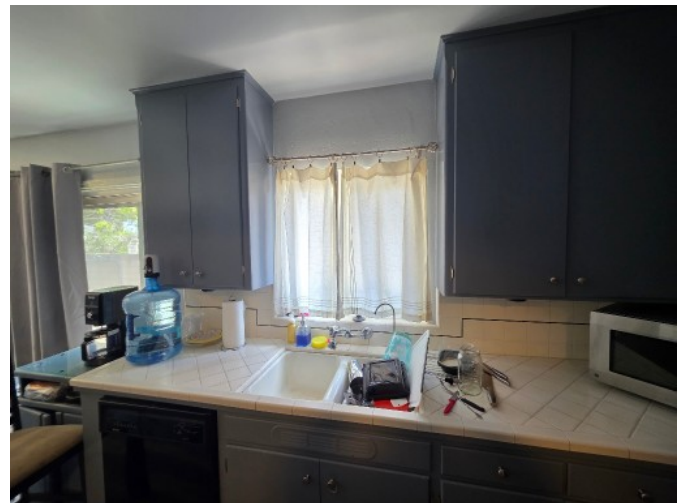
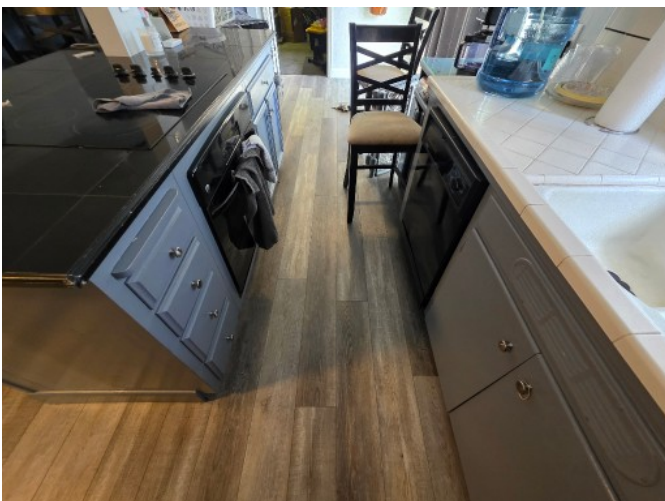
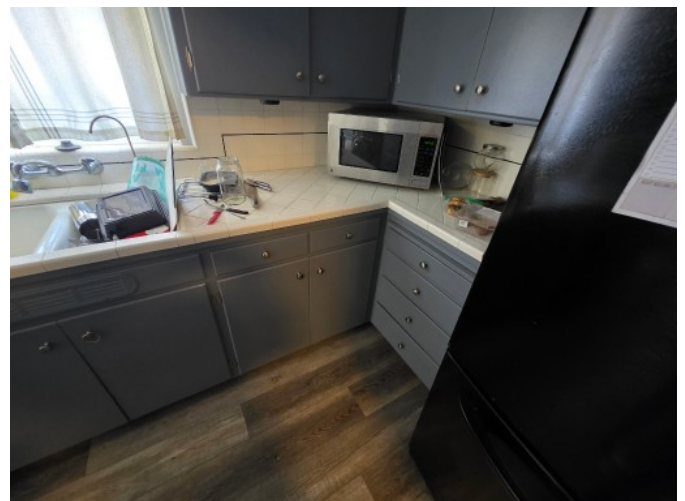
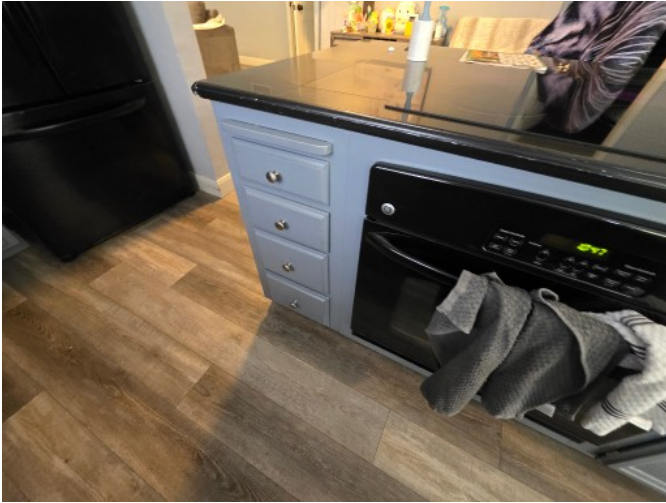
**12.11) Cabinet Conditions**

The kitchen cabinets appeared to be in serviceable condition at the time of inspection.
