# Inspection Report

**VALUE GUARANTEED INSPECTIONS**

1234 W Filmore Ave

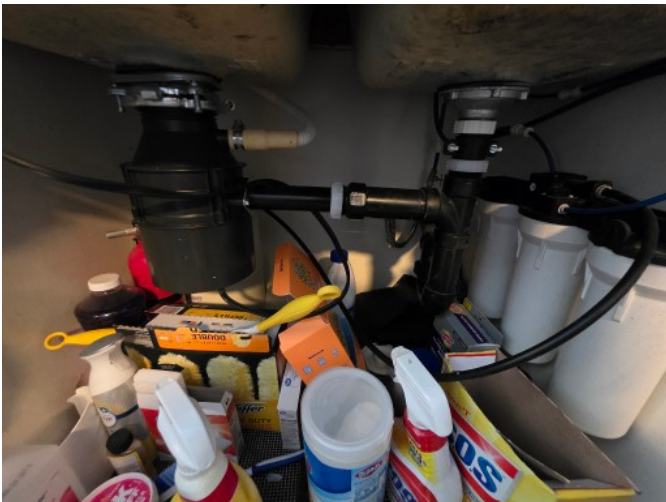
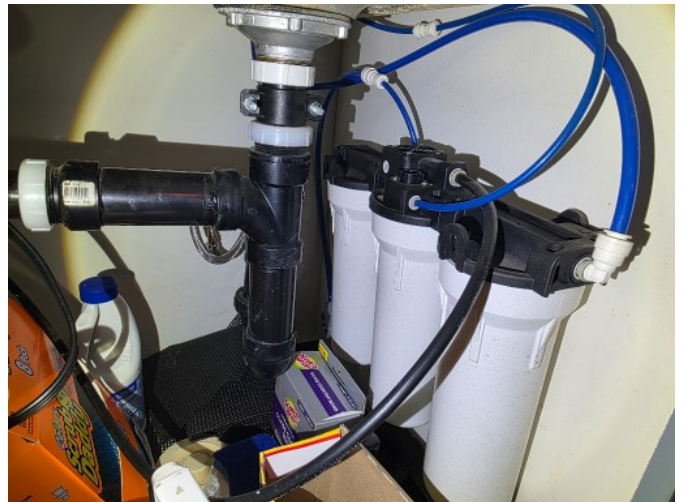
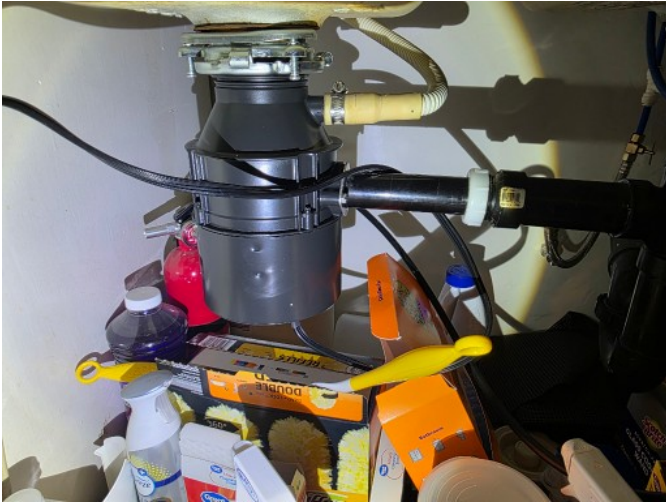
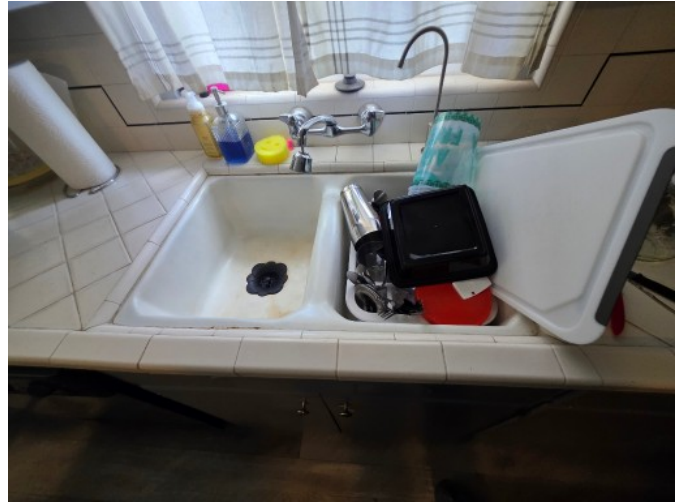
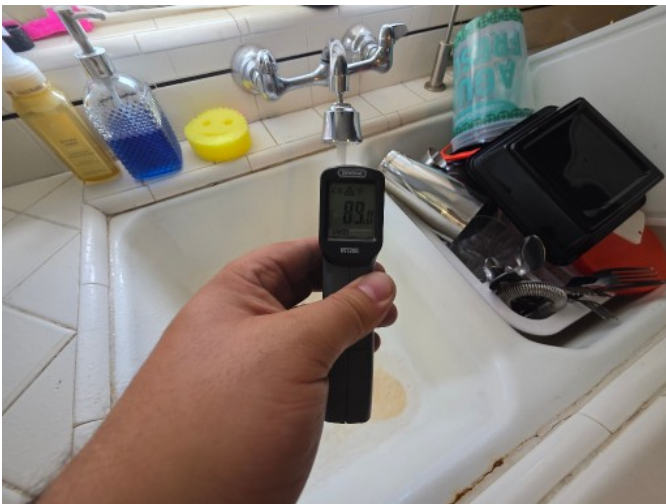
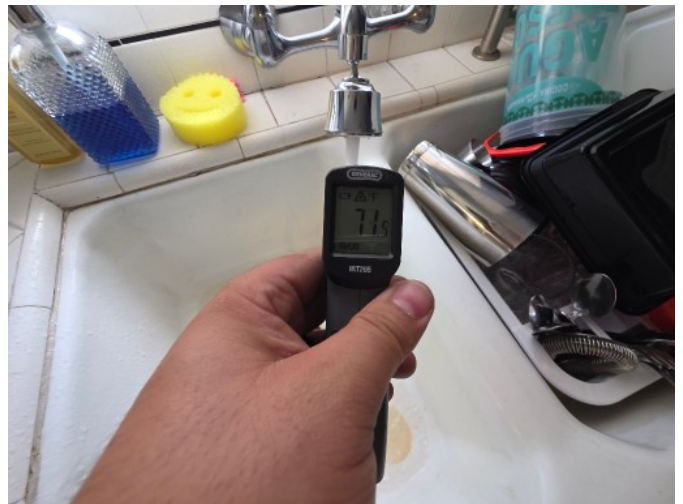
**12.12) Sink Plumbing Conditions**

The kitchen sink appeared to be in serviceable condition at the time of the inspection. The faucet appeared to be in serviceable condition at the time of the inspection. The visible areas of the plumbing under the kitchen sink appeared to be in serviceable condition at the time of the inspection. A water filter was present. Testing of operation, water quality or function is not performed as part of this inspection. The view below the sink was restricted due to personal item storage.

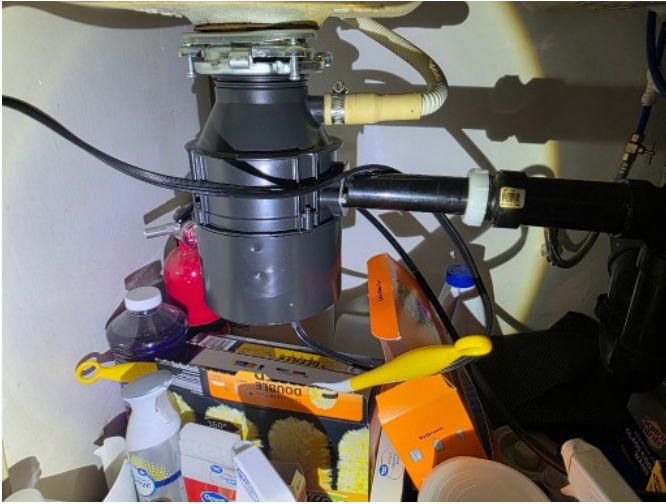
**12.13) Garbage Disposal Condition**

The sink disposal was operable at the time of the inspection. Client should consult a licensed plumber, manufacturer, or disposal supply company for information on proper usage and safety related concerns.

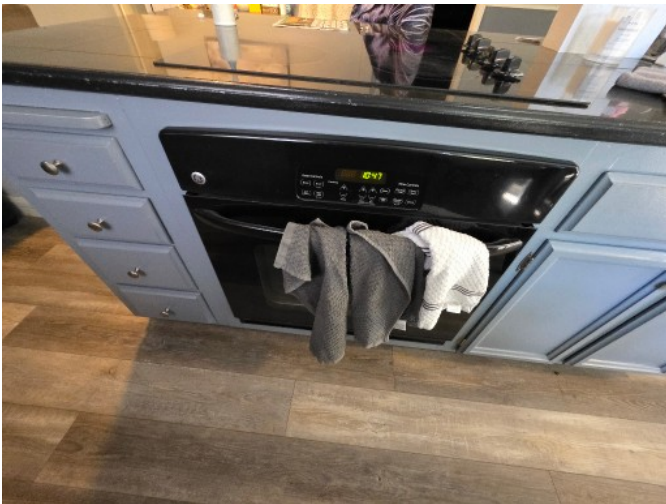
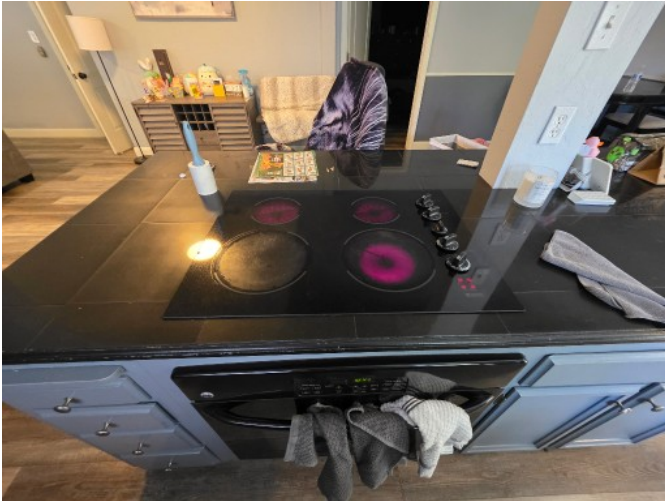
**12.14) Stove - Range Condition**

The oven was in operational condition at the time of the inspection. This does not however guarantee future conditions after the time of inspection.

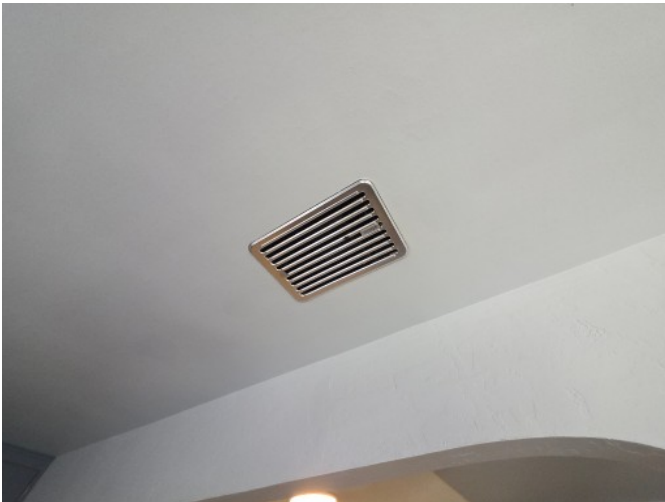
### 12.15) Hood Fan Conditions

The fan / hood and light were in operational condition at the time of the inspection. The fan was noisy at the time of inspection. Recommend adjustment and/or repair and / or replacement. This does not however guarantee future performance or conditions.

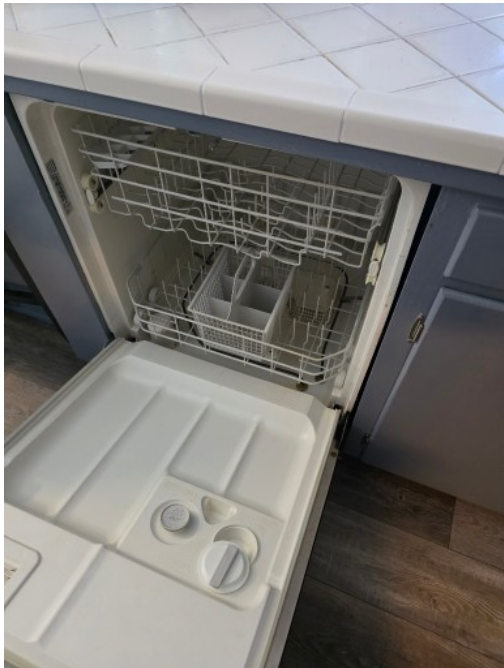
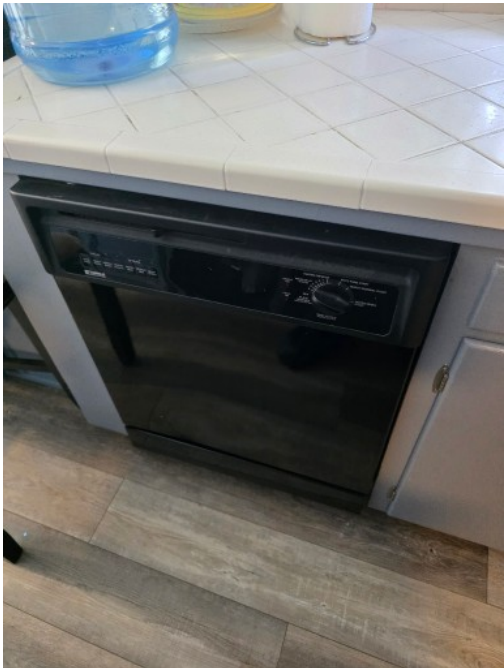
### 12.16) Dishwasher Conditions

The dishwasher appeared to be in serviceable condition at the time of the inspection. This does not however guarantee future performance or conditions. The door springs were broken or not operating properly. Recommend adjustment and / or repair.

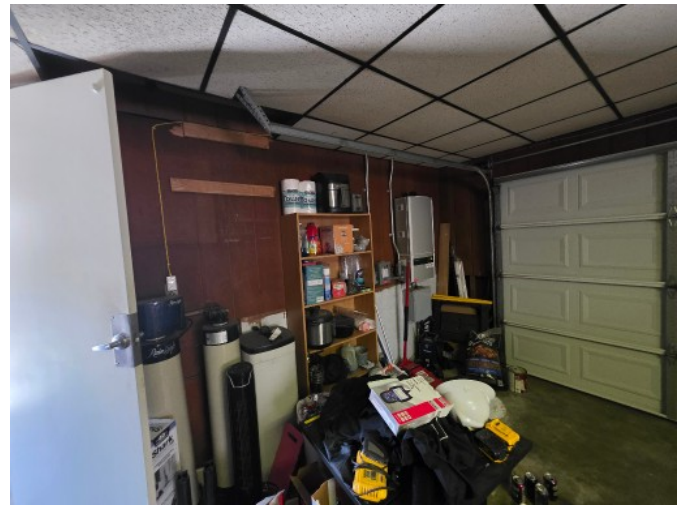
#### 13.1) Wall Conditions

Personal belongings and / or shelving prevented a full inspection of the entire wall. Moving or disturbing homeowner personal property is outside the scope of our inspection. The general condition of the walls appeared to be in serviceable condition at the time of the inspection.

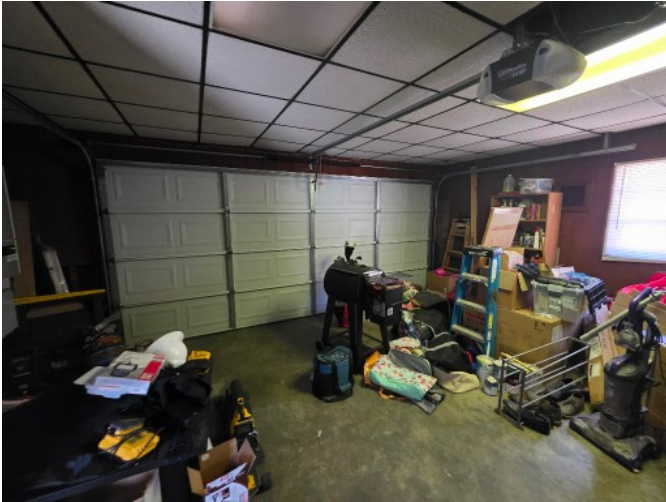
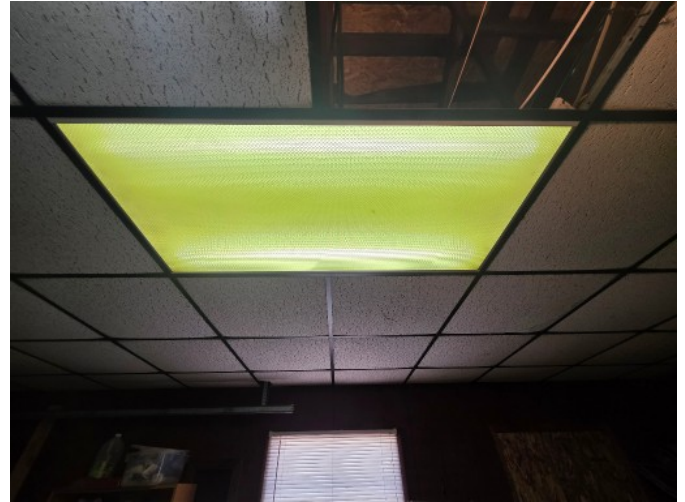
#### 13.2) Ceiling Conditions

The general condition of the ceilings appeared to be in serviceable condition at the time of the inspection. Drop ceiling type panels were present. The inspector was unable to fully inspect above tiles. A full inspection would require removal of all ceiling panels, which is not performed as part of this inspection.

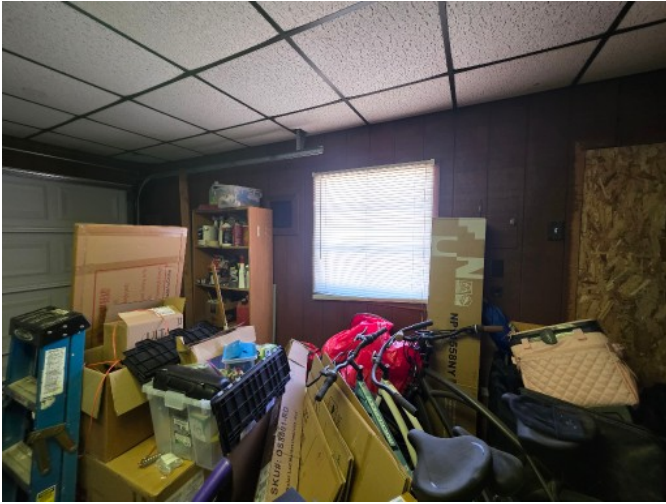
### 13.4) Window Conditions

Furnishings, personal item storage, and window treatments prevented a full visual inspection of all windows and window areas. Conditions can change between the time of inspection and closing. Please do a careful check of all windows during your final walk through.

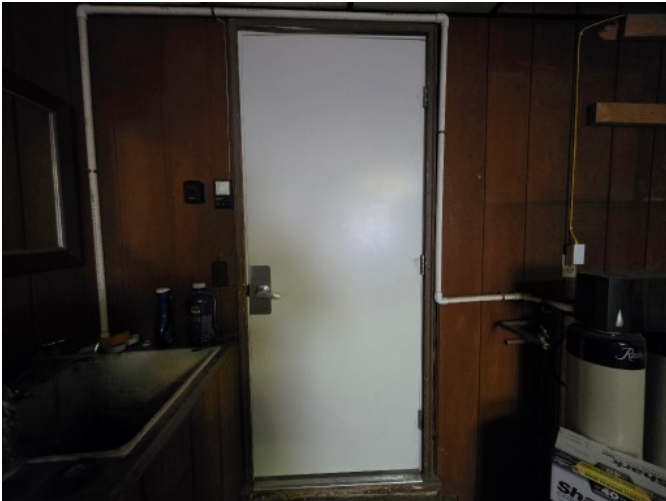
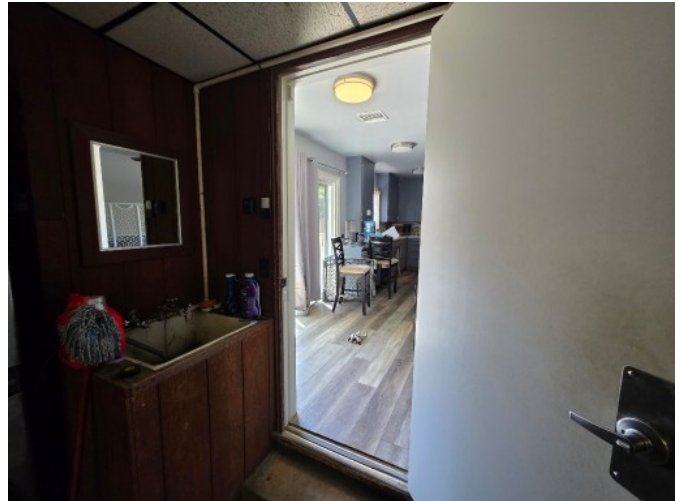
### 13.5) Door Conditions

The interior doors appeared to be in serviceable condition at the time of the inspection.  
The self closer on the door to living space was non-operational at the time of the inspection.

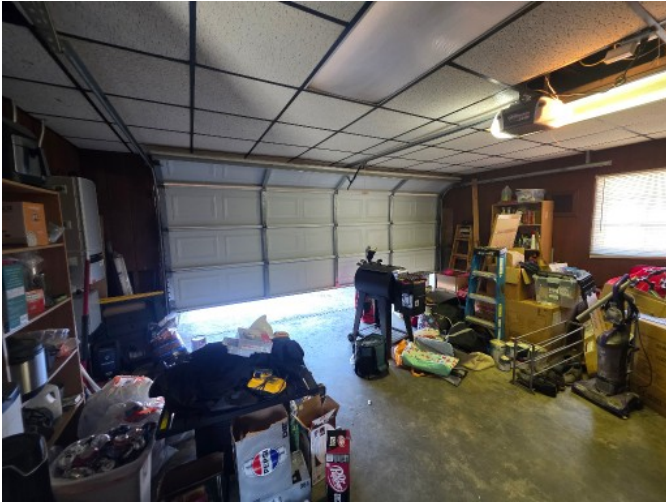
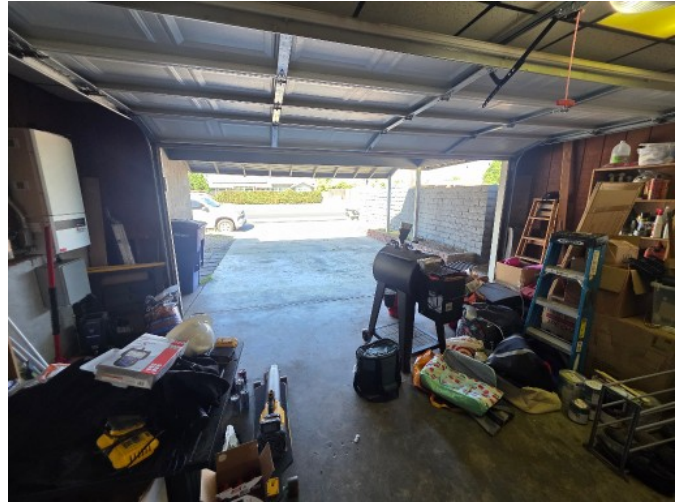
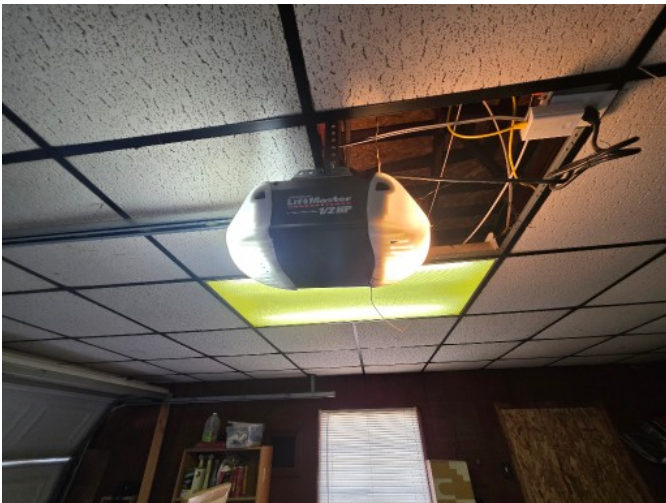
### 13.6) Vehicle Door Conditions

The vehicle door(s) appeared to be in serviceable condition at the time of the inspection. The vehicle door produced moderate noise/vibration during operation.

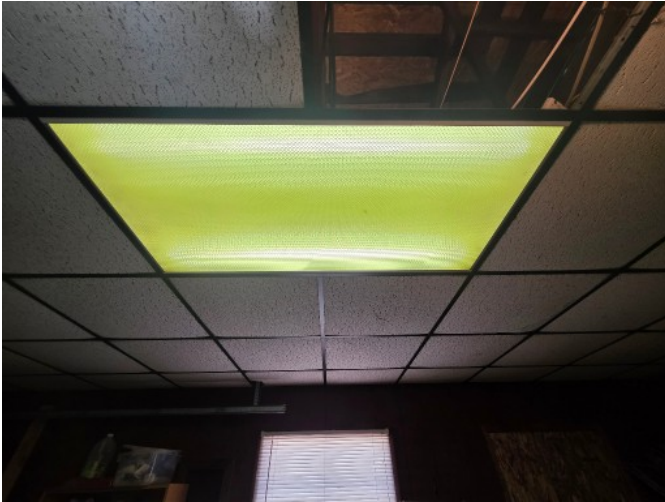
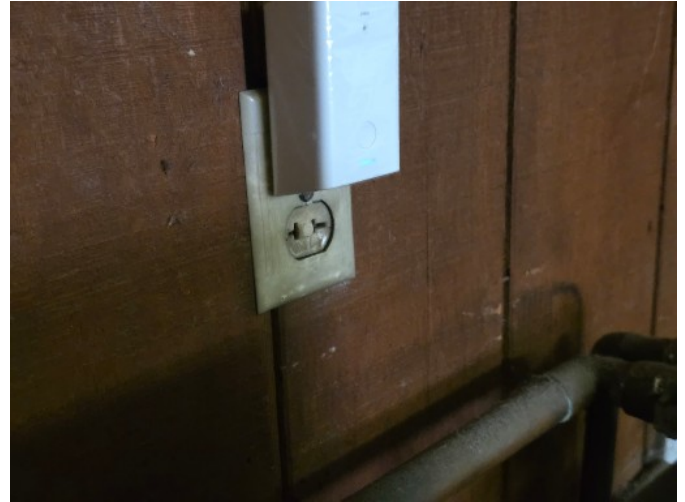
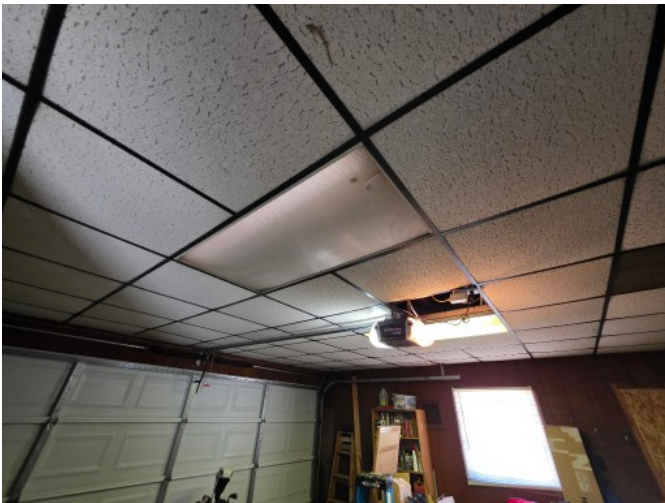
### 13.7) Electrical Conditions

Today's building standards require garage outlets to be GFCI protected. Recommend updating to enhance safety of the home/area. Minimal outlets were observed. Recommend adding outlets to reduce extension cord usage and to increase safety. A light bulb was missing at therefore the fixture and switch could not be tested. Two prong (non-grounded) receptacles were observed. Although these were commonly used years ago, we recommend a licensed electrician upgrade to grounded three prong receptacles.

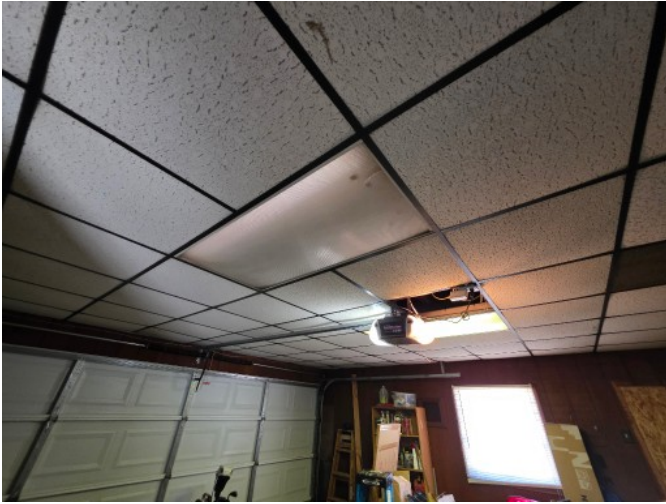
### 13.8) Lighting Conditions

Some lights failed to respond. There appears to be power to the fixture. Most likely bulb replacement is needed, however this may also indicate a problem with the fixture.

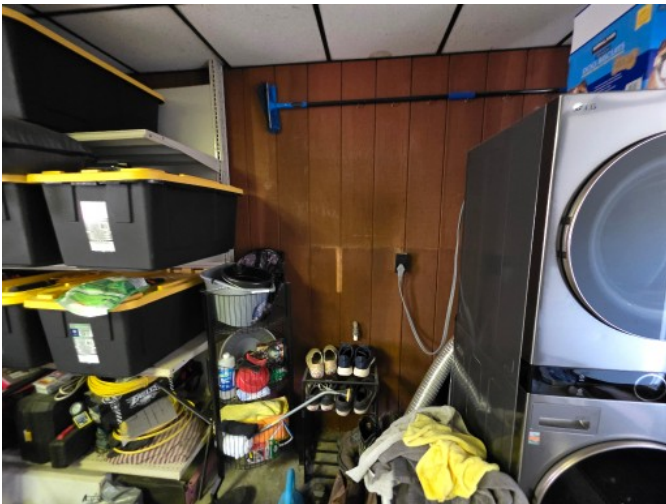
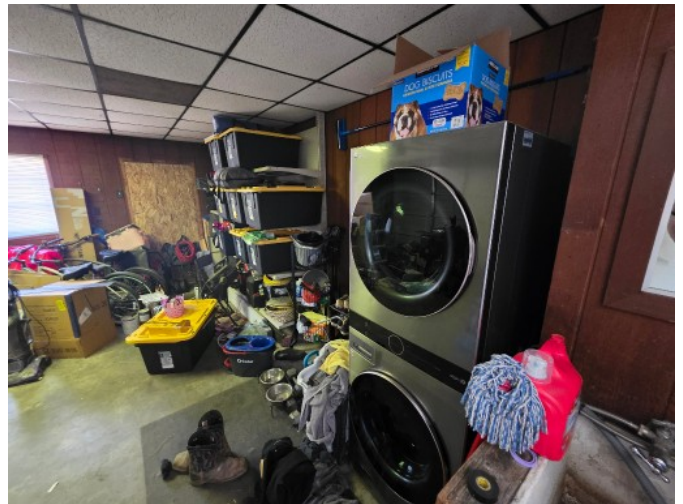
### 13.9) Laundry Room Conditions

Washers and dryers are beyond the scope of this inspection. Any information regarding these appliances is given as a courtesy only. Today's building standards require all electrical outlets within 5ft of a sink basin to be protected by a GFCI/GFI protector.

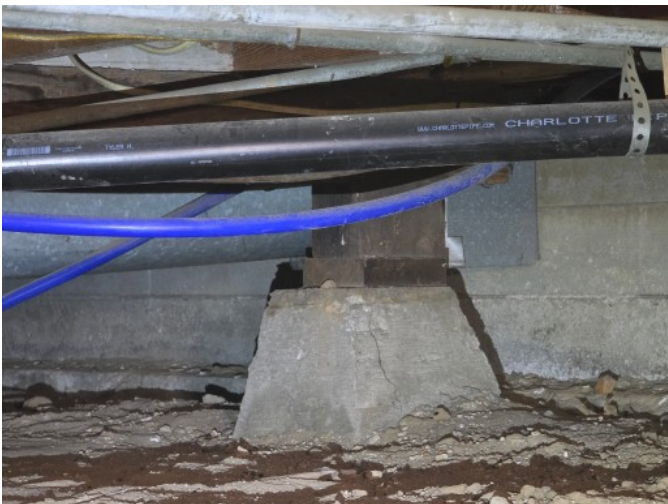
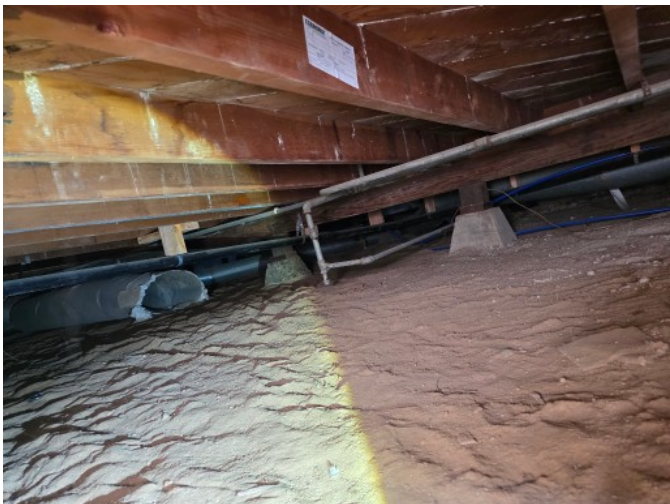
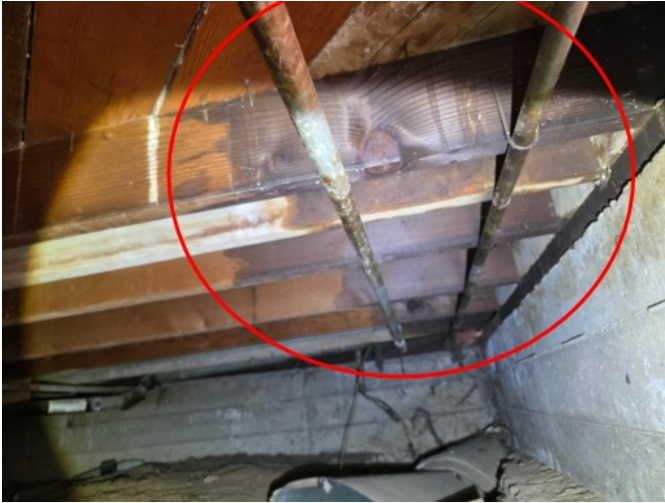
14.1) Foundation Conditions

Moisture stains were observed at the foundation walls. We suspect recent or active water penetration. Client should obtain history / disclosure information from seller and / or consult a waterproofing contractor. Furnishings and personal item storage prevented a full visual inspection of all areas. The perception of floor conditions can differ from when furnishings and personal items storage is present to an area that is vacant with a clear view and access of the entire surface / area. Client is advised to perform a careful check of all areas during final walk-through, including, but not limited to, any floor sloping or adverse conditions that may not have been readily observed during the time of original inspection. Such conditions should be brought to your Realtor (if applicable) or Attorney's attention prior to closing of this property. The only visible portions of the foundation were found in the garage due to floor coverings in the home. This area appeared serviceable.

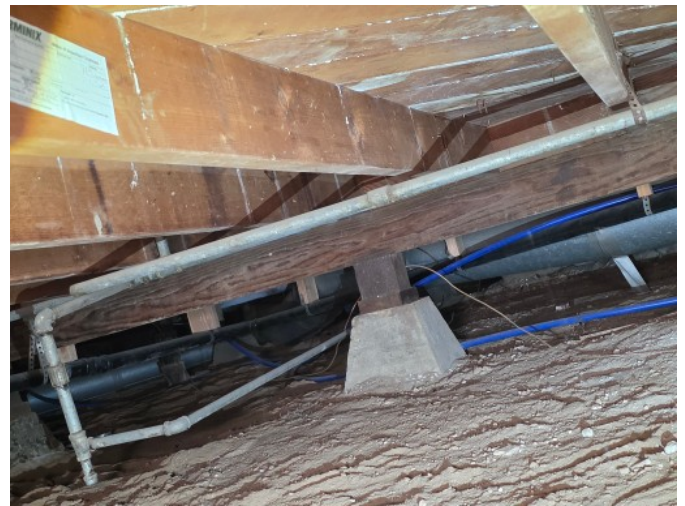
The column / support is 4 X 4 posts. The wood framing floor system was constructed of 2 X 12 floor joists. The support framing was constructed of 2 X 10 beams.

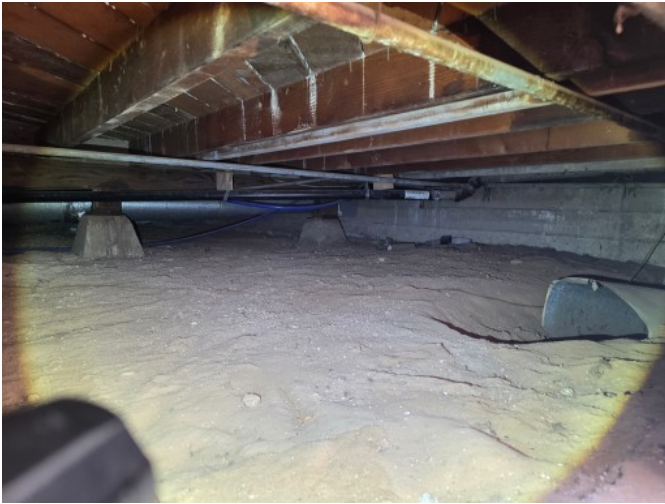
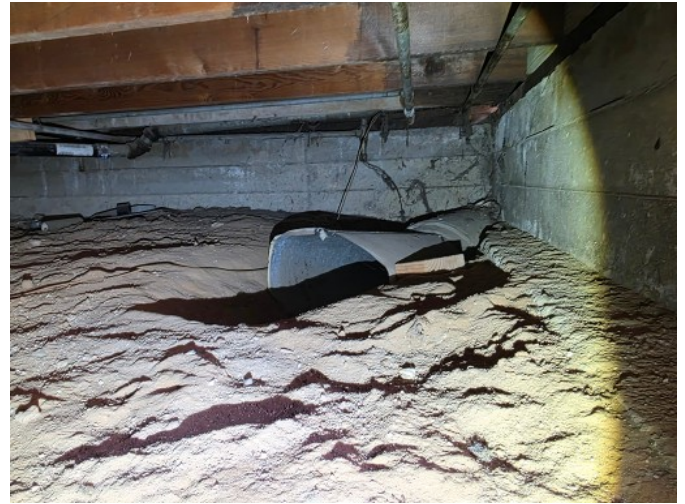
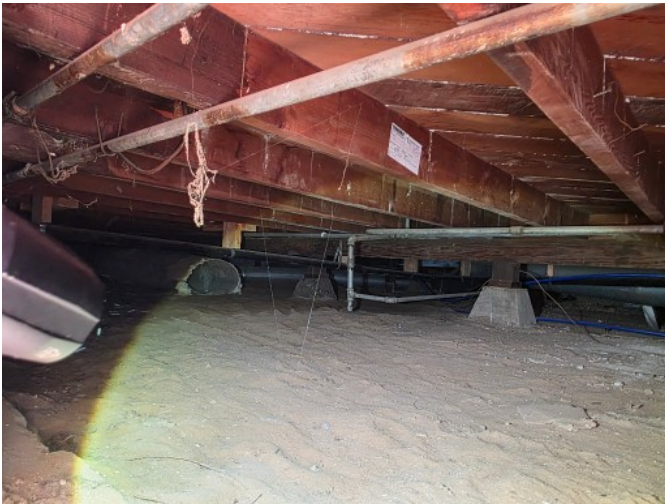
**14.2) Flooring Support Conditions**

The visible and accessible areas of the wood framing system appeared to be in serviceable condition at the time of the inspection.
